22 Aug 2013

Serendra Explosion Incident

Final Report – Part Two

Contributory and Associated Factors

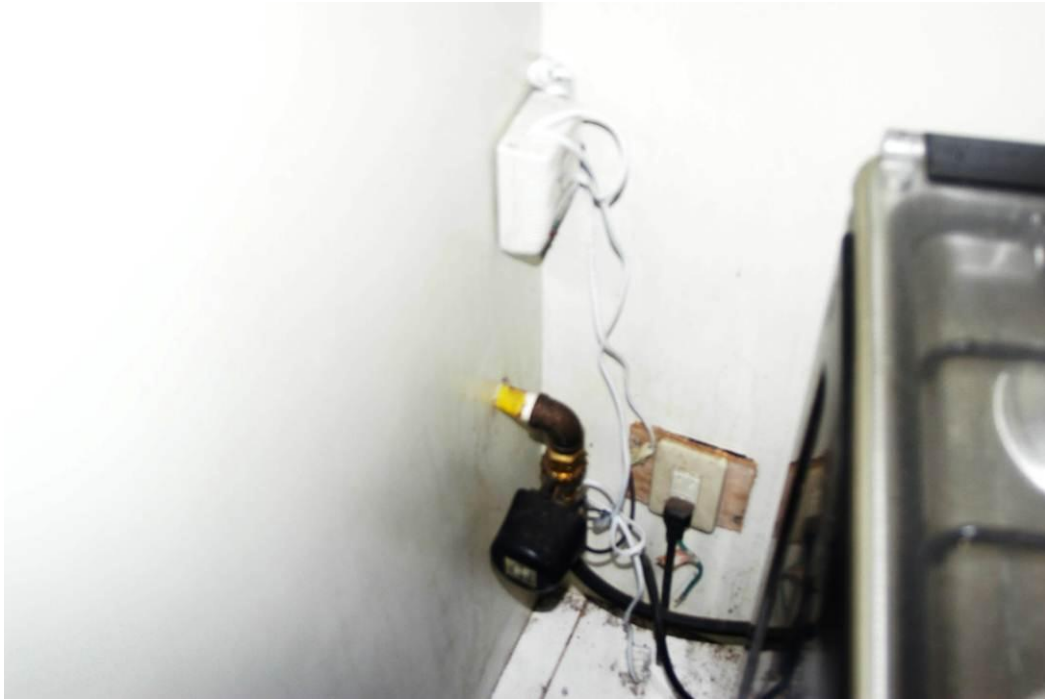
3. Examination of a unit with a mirror-image layout (303B) indicated that the socket outlet closest to the range and thus normally used for the detector was on the end wall of the kitchen, forming part of a double outlet also supplying the range. The detector was on the side wall directly above the shut-off valve, approximately 0.8m above floor level. This would allow a substantial vapour accumulation at low level before the 20% LEL threshold was reached at the detector height. In this unit, the detector was not plugged in when examined.

Figure 48 – gas detector, shut-off valve and power supply in Unit 303B
Note double socket outlet on end wall, only range plugged in
