Serendra Explosion Incident

Final Report – Part One

The Incident, Its Origin and Immediate Cause

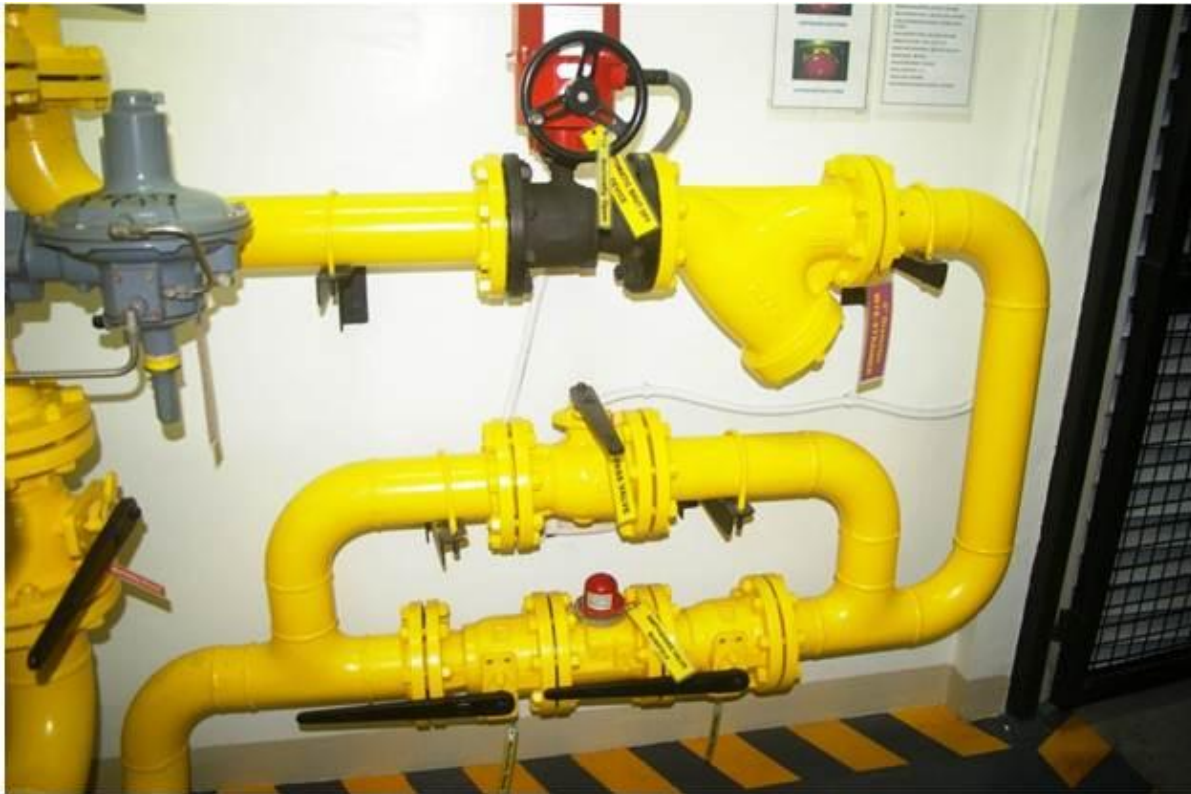
11. In the basement meter room there were three shut-off valves for the incoming supply. One of these was an earthquake sensor valve, one was connected to a gas detector and the third was a manually operated by-pass valve. There were operating instructions for the earthquake valve displayed on the wall but none for the leak detector valve.

Figure 1 – shut-off valves in basement meter room

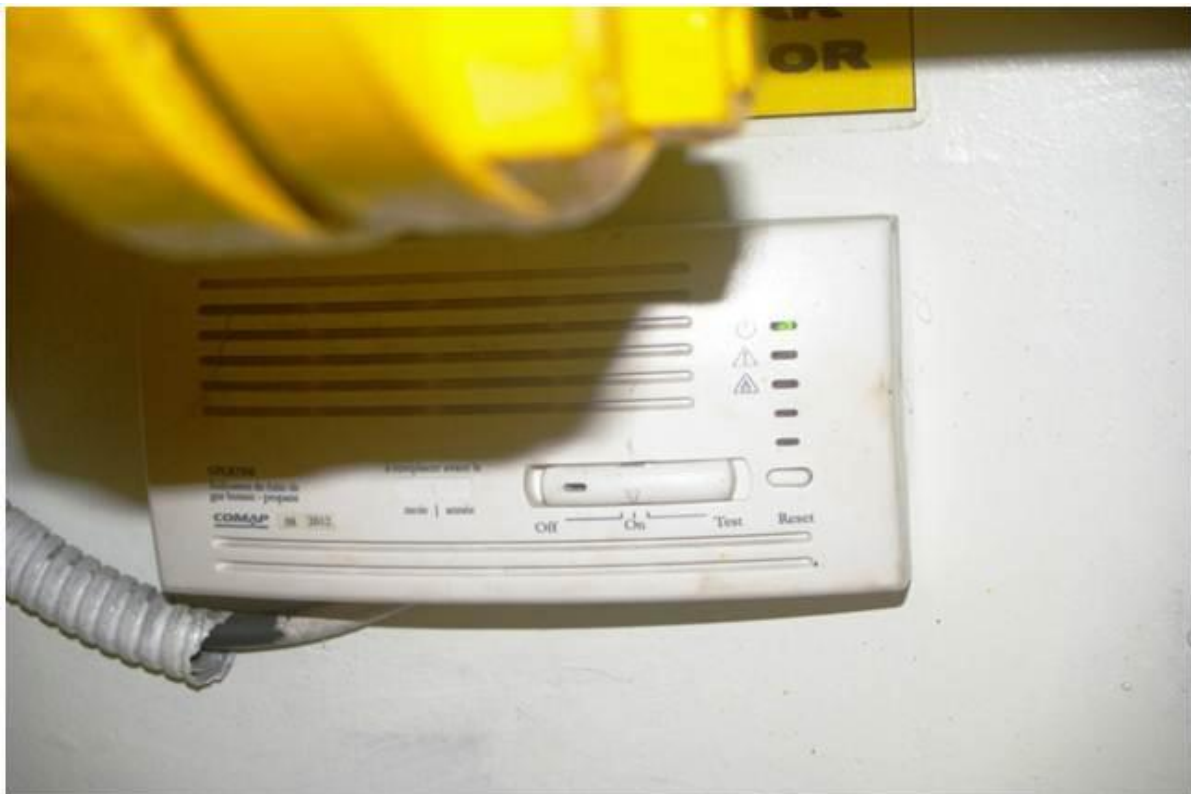
13. The valve to which the detector was electrically connected was a 'normal-on' type, which would be closed electrically on receiving a signal from the detector. This differs from a 'normal-off' or 'fail-safe' valve, which is held open electrically against a spring or gravity closer and shuts automatically if the sensor detects gas and interrupts the supply. The latter will also close in the event of electrical power loss, whereas the type fitted in basement 1 would stay open.

Figure 2 – gas detector in basement meter room, showing manual slide switch on front panel

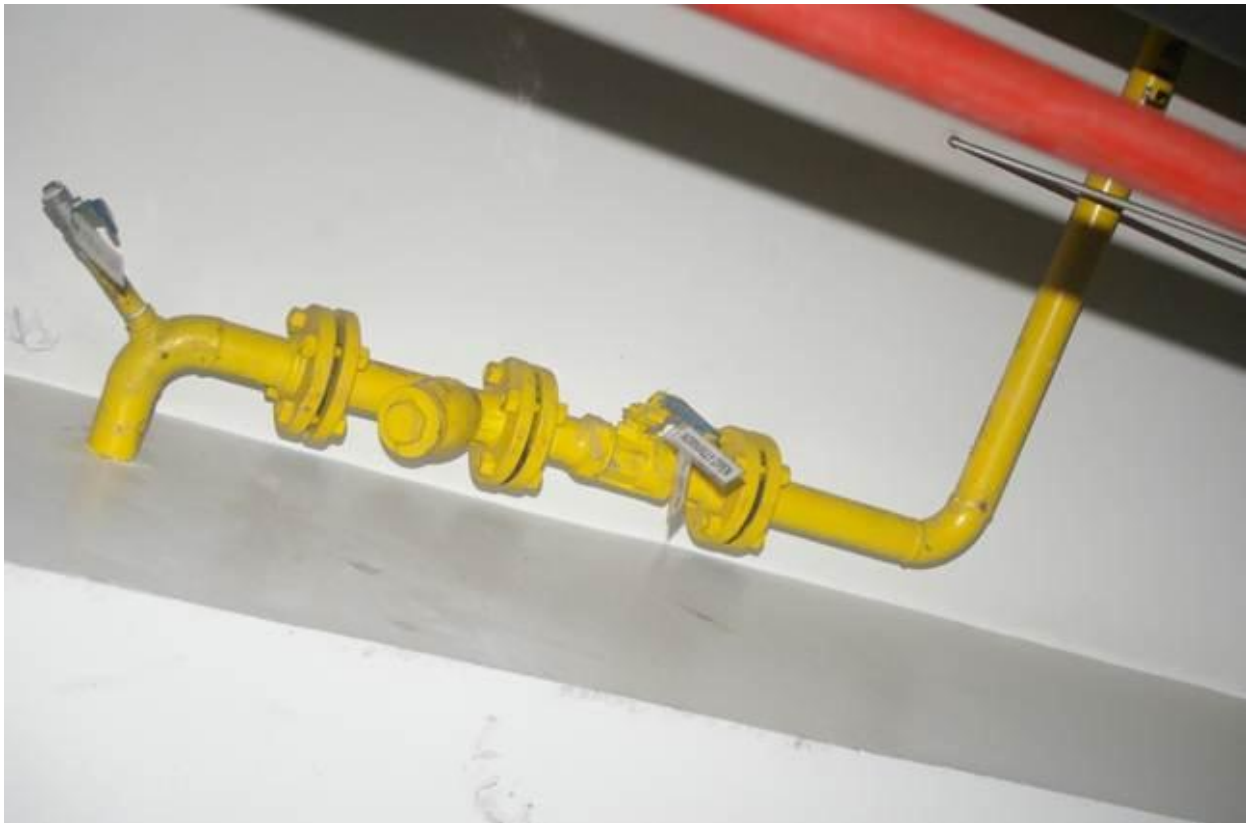
15. From basement 1, the BA Tower riser passed through a vertical pipe chase or duct behind the meters outside Units 101B-801B and entered the roof space above the east wall of 801B. At each floor level, the dropper and sub-meter for the unit was located in front of the riser. It was noted that this chase was continuous from ground floor to roof, with no firestopping or other sealing where it passed between levels.

Figure 3 – Tower BA riser penetrating basement 1 ceiling to ground floor outside Unit 101B

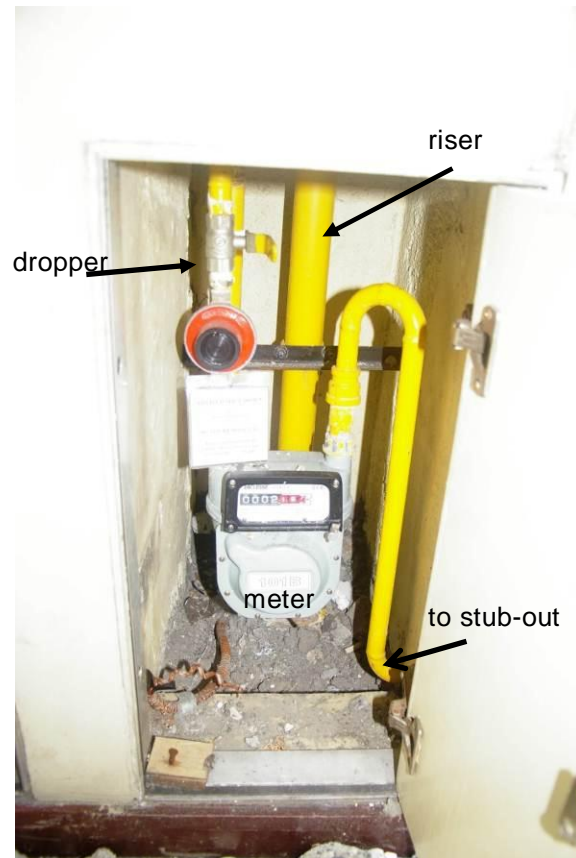
Figure 4 – Unit 101B meter cupboard

17. At the time of inspection, the meter cupboard outside 101B contained no gas detector although its flexible wiring sheath was present. This detector was removed for testing after the incident and found to have been switched OFF. When powered up by connection to a 220V supply, it was inoperative. It is understood that the detector was connected to the alarm panel and provided an audible warning. There was no associated shut-off valve on the riser.

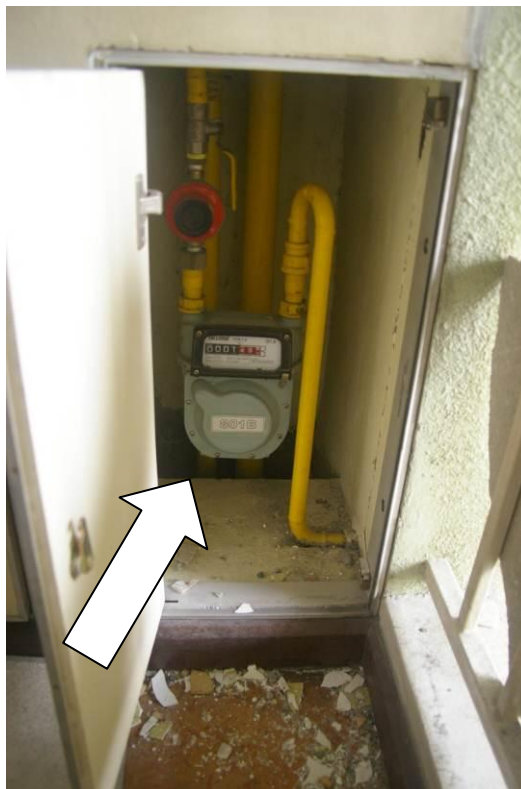
16. In the roof, the riser became a horizontal distribution pipe with droppers passing down beside flats 101B to 801B and between 103B-105B and 803B-805B on the north side of the corridor. Further horizontal pipes led above the 8th floor corridor ceiling to corresponding droppers serving units on the south side of the Tower. The dropper chases were also continuous from roof to ground floor with no seals or firestops.

Figure 5 – Unit 201B meter cupboard, showing open duct rising from ground floor level

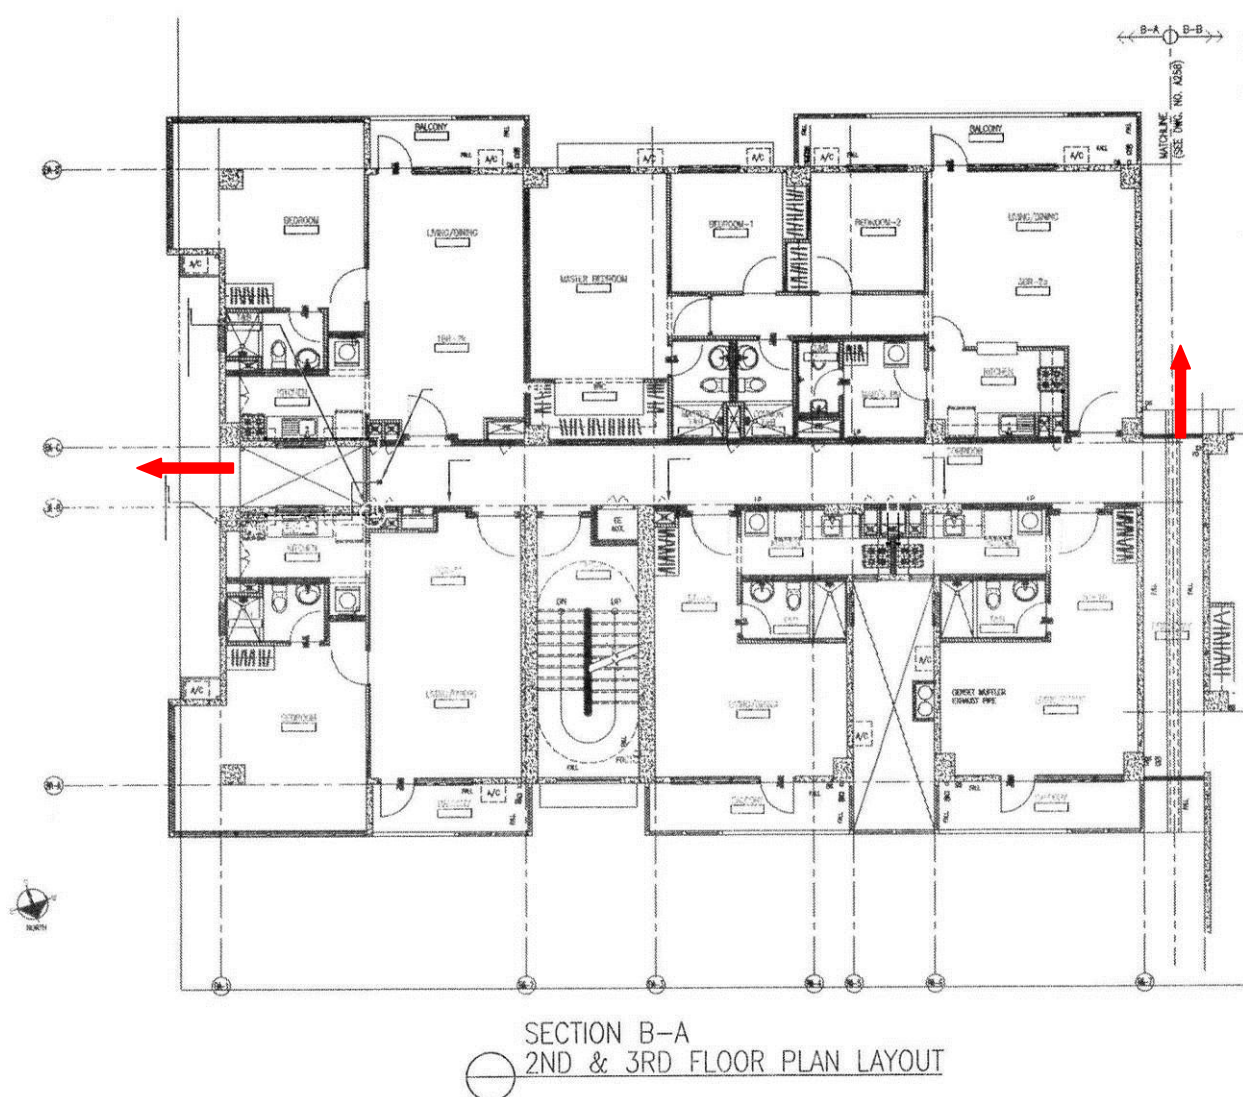
20. There was external venting from the open ends of the internal corridor at each level, with further external venting at the open south end of the link corridor between Towers BA and BB. Much of the excess pressure had dissipated to atmosphere at these openings, which had further limited the internal structural damage. Venting locations to atmosphere from Tower BA are marked with arrows in figure 6 below.

Figure 6 – example floor plan showing Tower BA layout above ground floor,
copied from Makati Development Corporation plans

Red arrows show venting to atmosphere

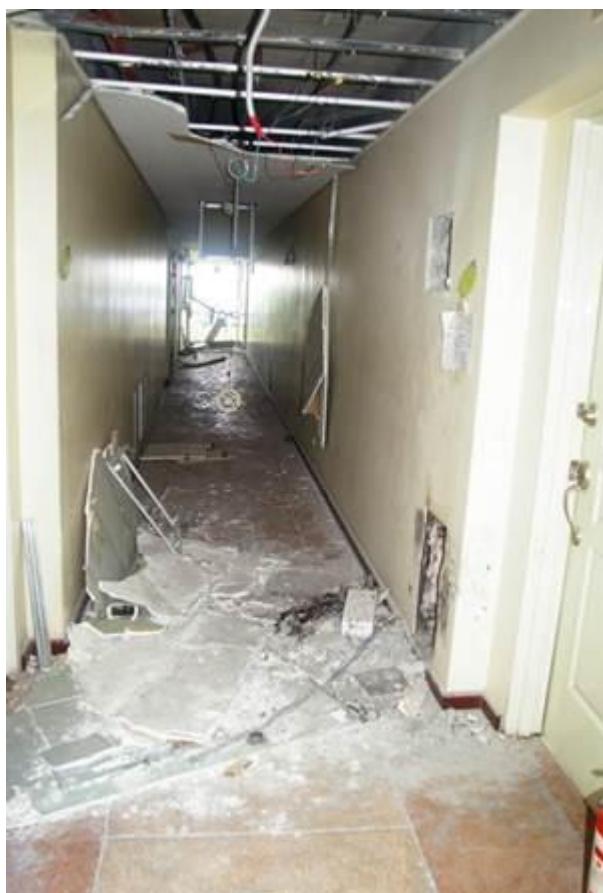
21. As a result of the overpressure in the corridors, many of the units had suffered failure of their entry doors and disturbance or breakage of the internal contents. Hosereel cabinet glass doors had failed on all levels of both Towers. There were also some structural effects such as cracked walls and broken windows inside units on Level 5, closer to the source of the explosion.

Figure 7 – Tower B, Level 3 corridor,
view E from link corridor

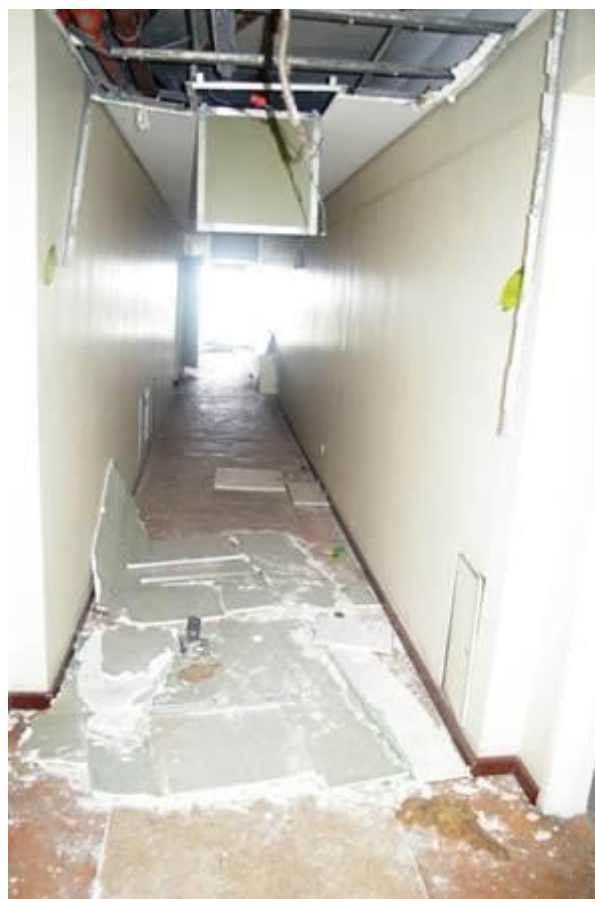
Figure 8 – Tower BA Level 6 corridor,
view E from link corridor

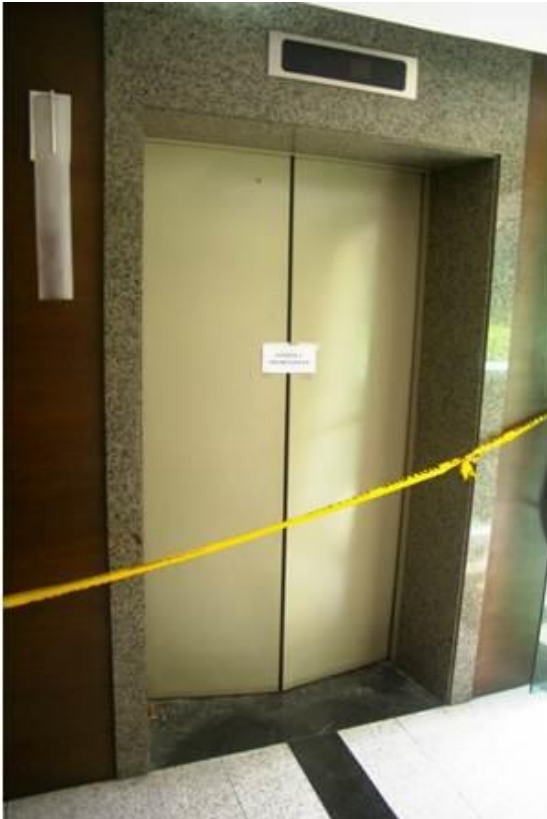
22. The second route of travel for the pressure wave was via the elevator shafts, with distortion to the doors at Levels G and 5 and the cars jammed inside. The effect of the pressure wave at the moment of impact on the elevator cars is visible in the CCTV recordings. The white smoke-like substance seen in those images and reported by several eye-witnesses was probably composed largely of dust particles.

Figure 9 – ground floor elevator doors

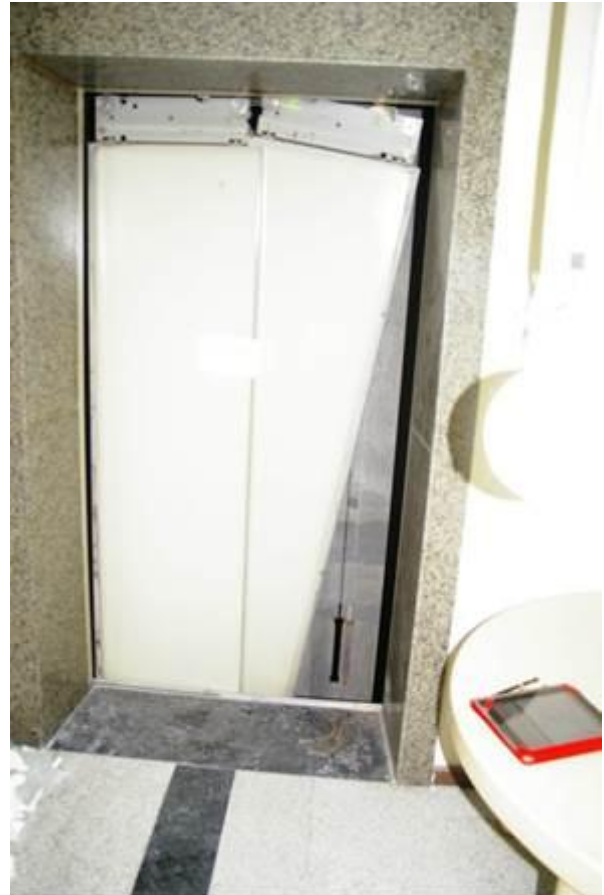
Figure 10 – level 5 elevator doors

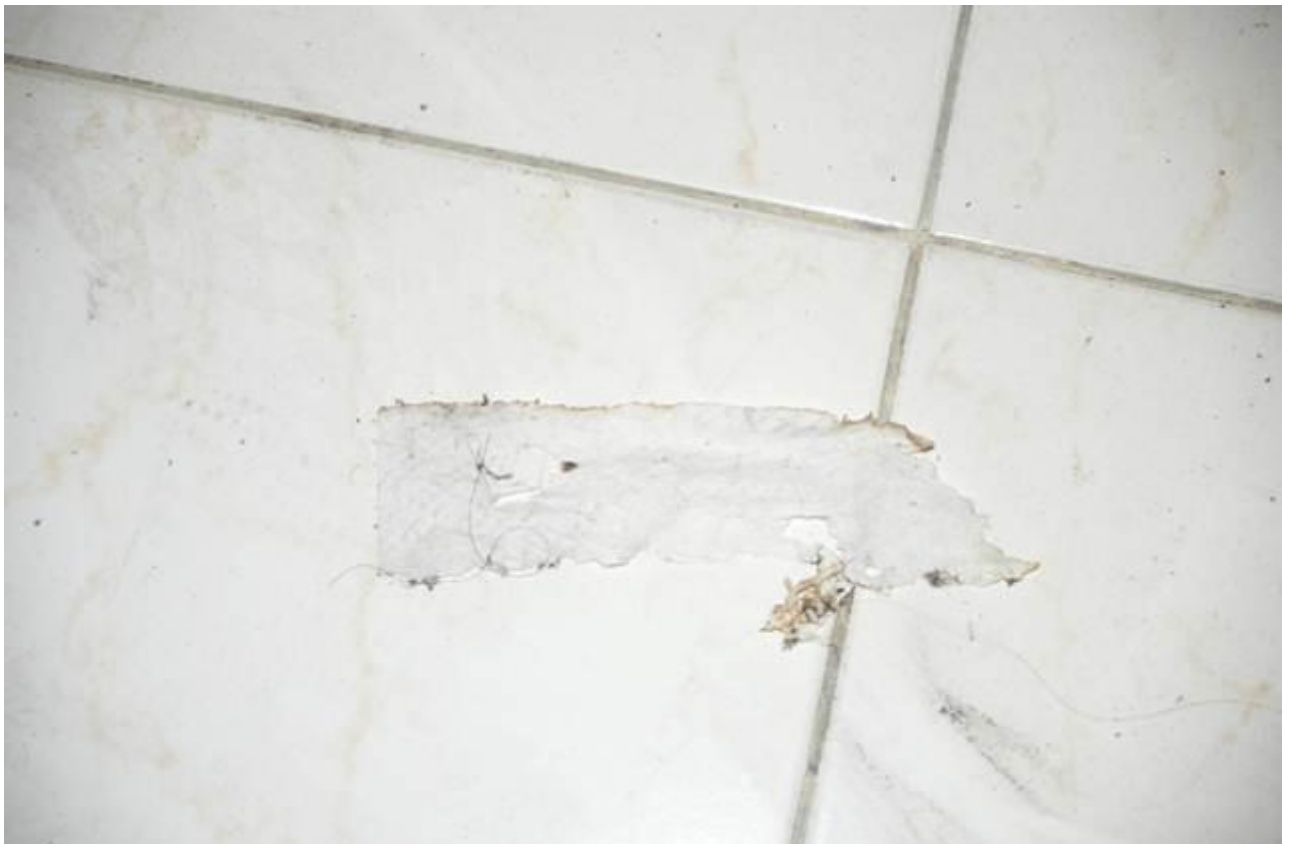
28. Among these indicators were scorching to the exposed edges of plasterboard backing paper, slightly melted and scorched fabrics and plastics in units on Levels 3 and 6. The farthest locations from 501B in which transient flame damage was found were Unit 706B, where some scorched paper towel was lying on the floor, and Unit 201B where curtains at the north window were singed. Although the paper in 706B could have been transferred in from outside during the post-incident activities, the curtains in 201B had remained in position.

Figure 11 – scorched paper towel on floor in Unit 706B

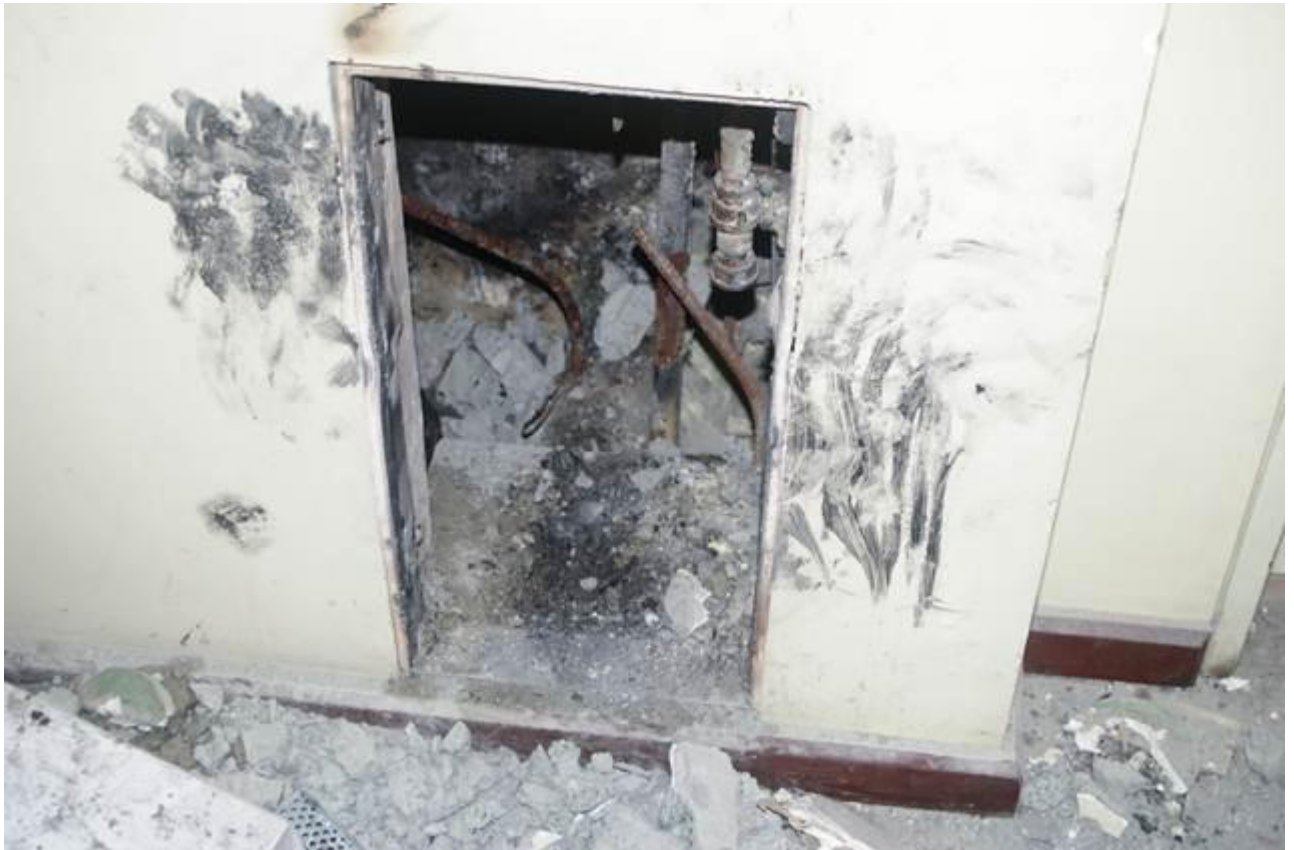
29. There was an area of more prolonged burning outside Unit 306B where a small fire had occurred inside the LPG meter cupboard. This was consistent with displacement of the meter and piping by the overpressure causing a gas escape and ignition. Localised flaming then continued until the building supply was shut off at approximately 20:10-20:15. Remains of the meters from this cabinet and that of 506B above were recovered from there by IATF and later examined at the NBI laboratory.

Figure 12 – Unit 306B meter cupboard

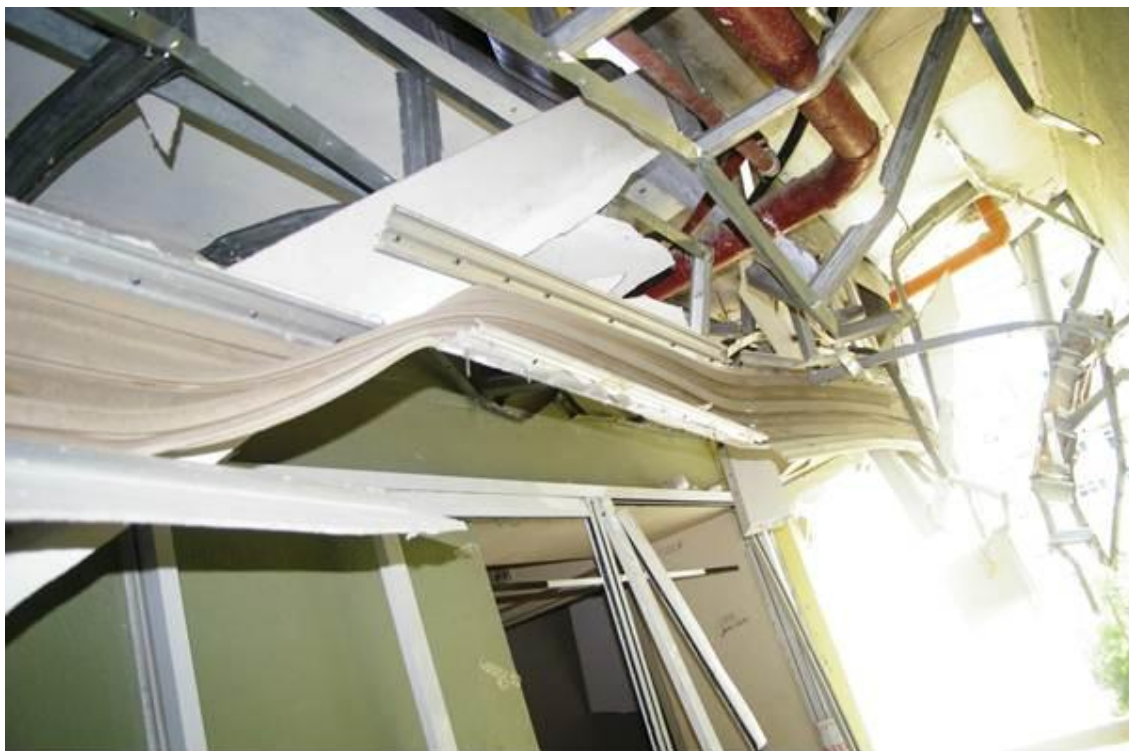
25. At Level 5 of Tower BA, there was a different pattern of damage. The utilities cabinet doors were pushed in and the ceiling had both lifted and then collapsed. At the link corridor there was upward displacement of the earthquake joint cover on Level 6 above, combined with downward displacement and twisting of the vertical cable tray in the ceiling space.

Figure 13 – Level 5 link corridor ceiling and cable tray, view South-East

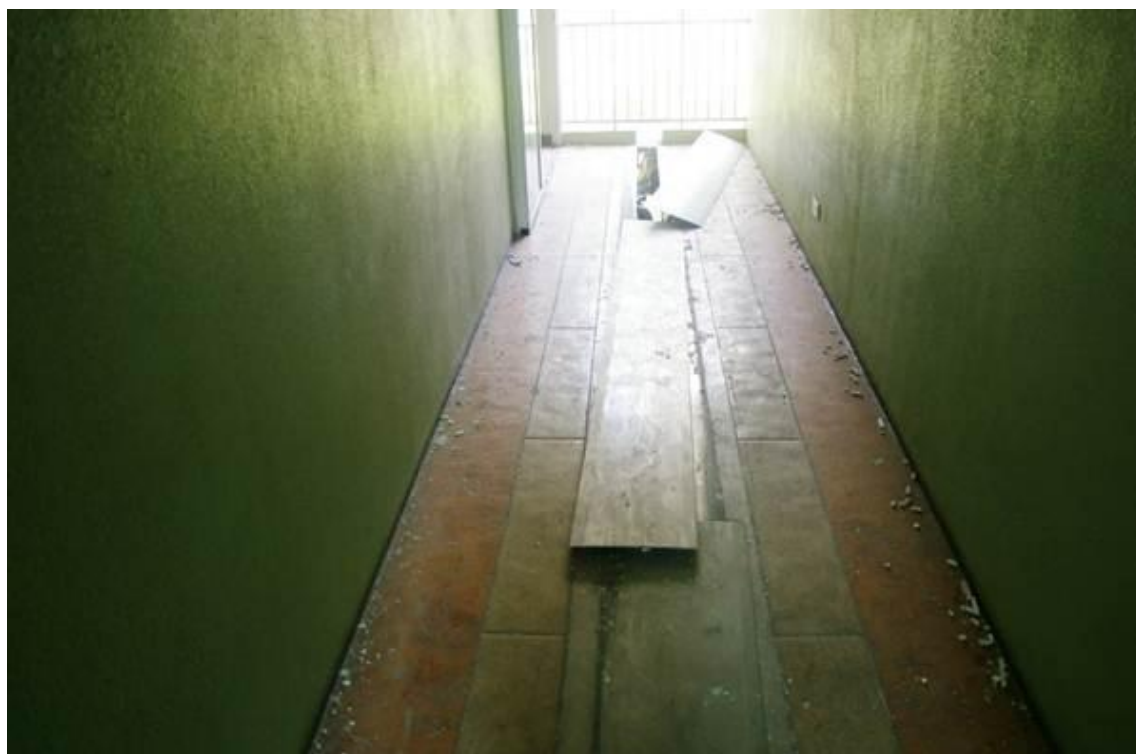
Figure 14 – Level 6 link corridor, view South showing lifted steel plates

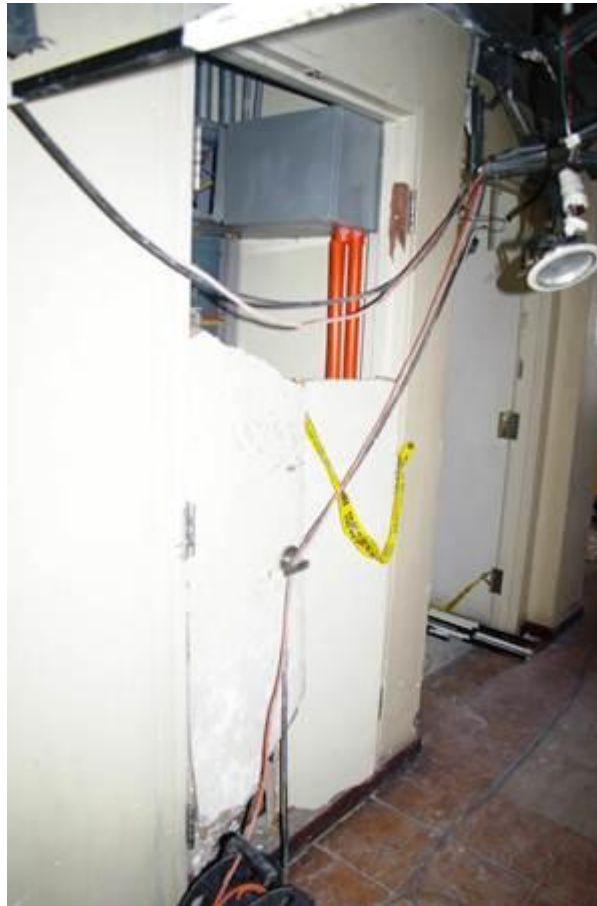
Figure 15 – Tower BA Level 5 utilities cabinet and fire exit

33. On the north side of the corridor, both Units 503 and 505 had doors forced in, with considerable internal disruption, north walls and windows displaced outwards and ceiling failures. The utilities enclosure doors between 503 and the fire exit stairs were pushed inwards from the corridor, and the heavy steel fire exit door was projected into the stairwell.

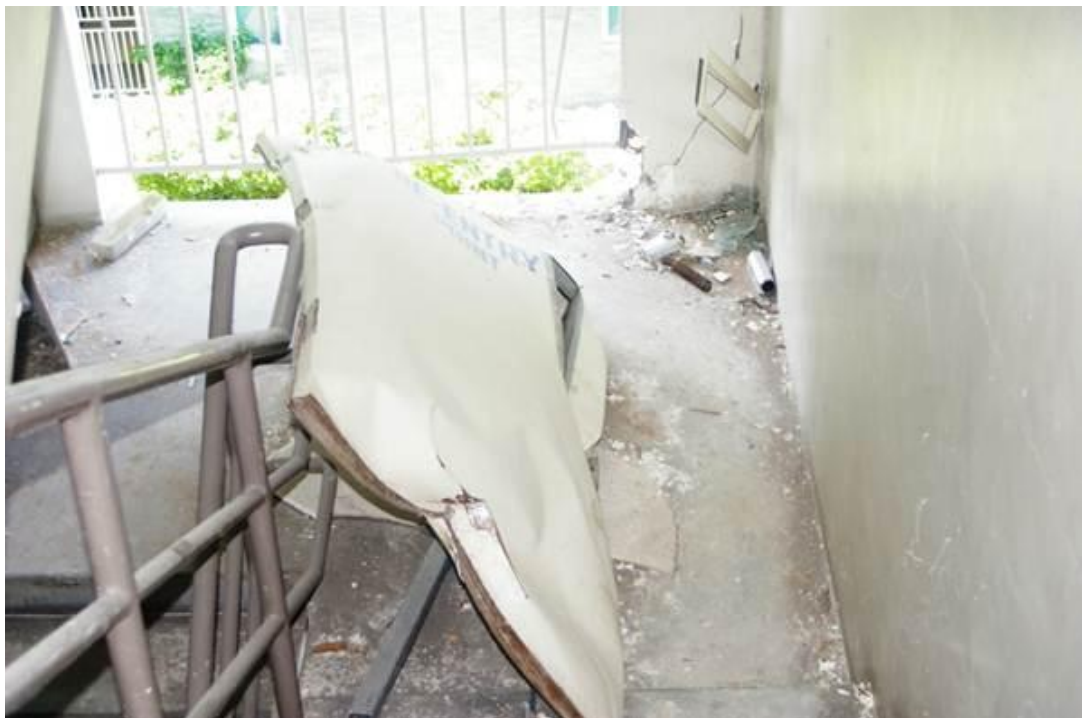
Figure 16 – Tower BA Level 5 fire exit door projected into stairwell

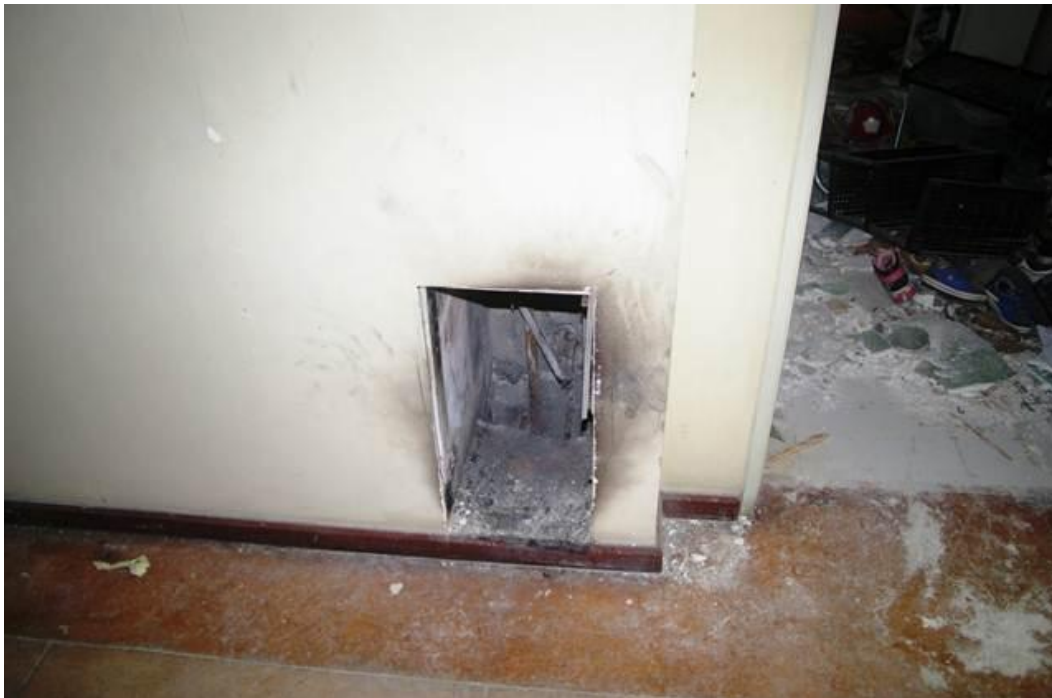
35. There was burning inside the meter cupboard for Unit 506 similar to but slightly more severe than that at 306. This was also consistent with flaring of escaping gas during the period between the explosion and the shutting off of the main supply.

Figure 17 – meter cupboard outside Unit 506B

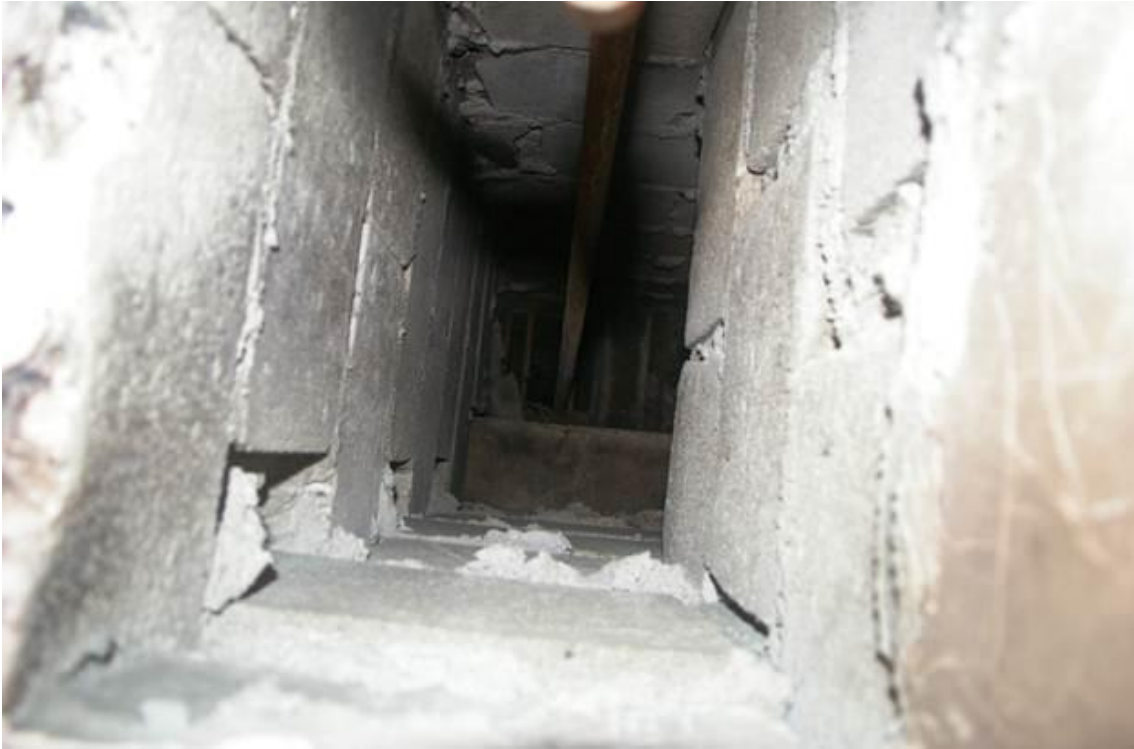
37. On looking inside the meter cupboard, it was apparent that numerous gaps and channels were present in the block wall and mortar construction between the meter cupboard interior and the sealing strip. It was considered most probable that heat and smoke transfer took place through these gaps and ignited the exposed sealing strip while the escaping gas was burning.

Figure 18 – duct above 506B meter cupboard, open to roof level, showing gaps in block and mortar construction; North face to left of image

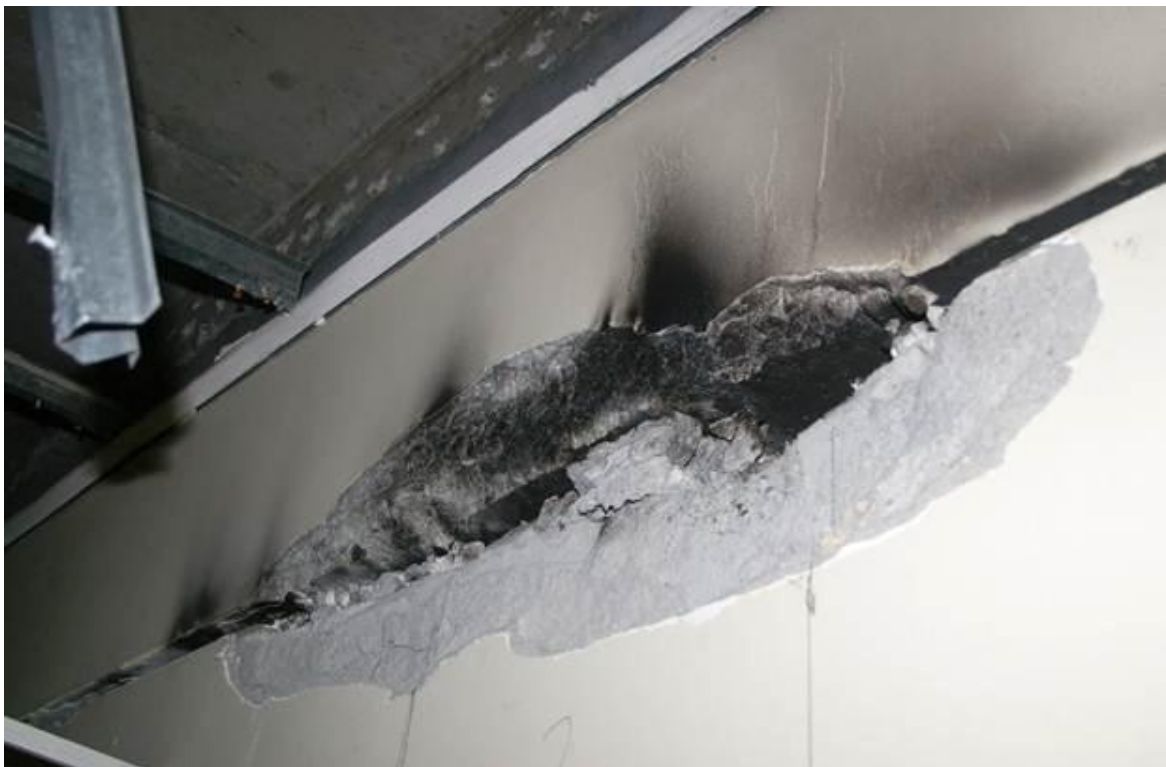
Figure 19 – burning at cracked wall above and East from 506B meter cupboard

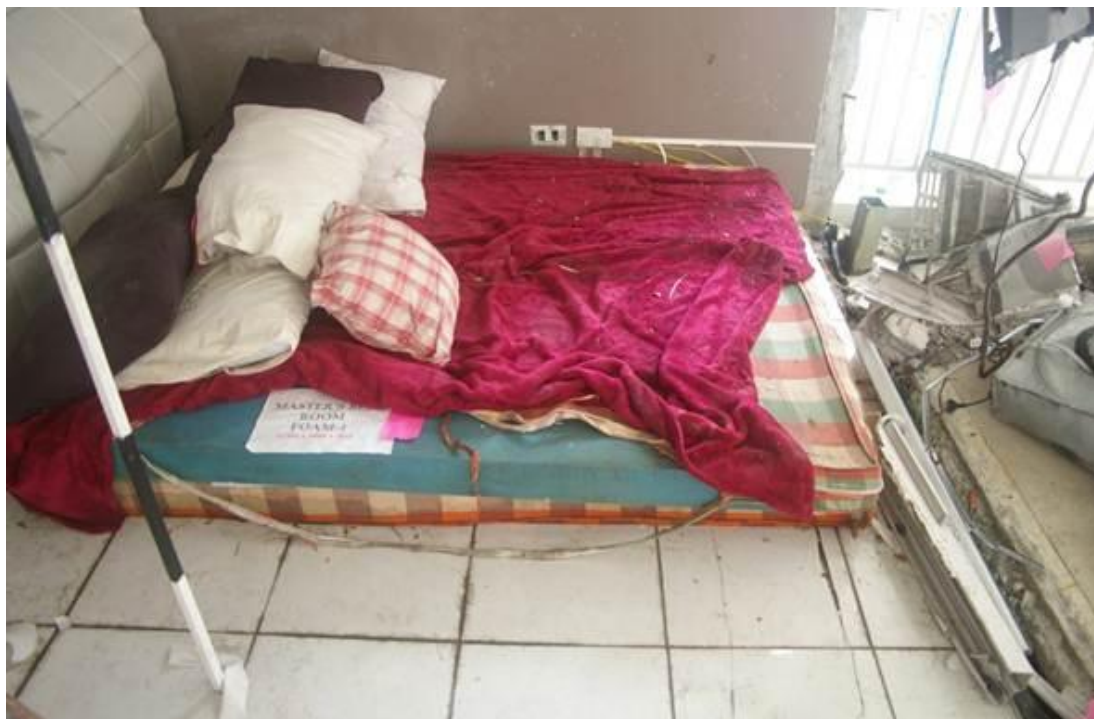
Figure 21 – heat and flame damage to bedding in bedroom 1

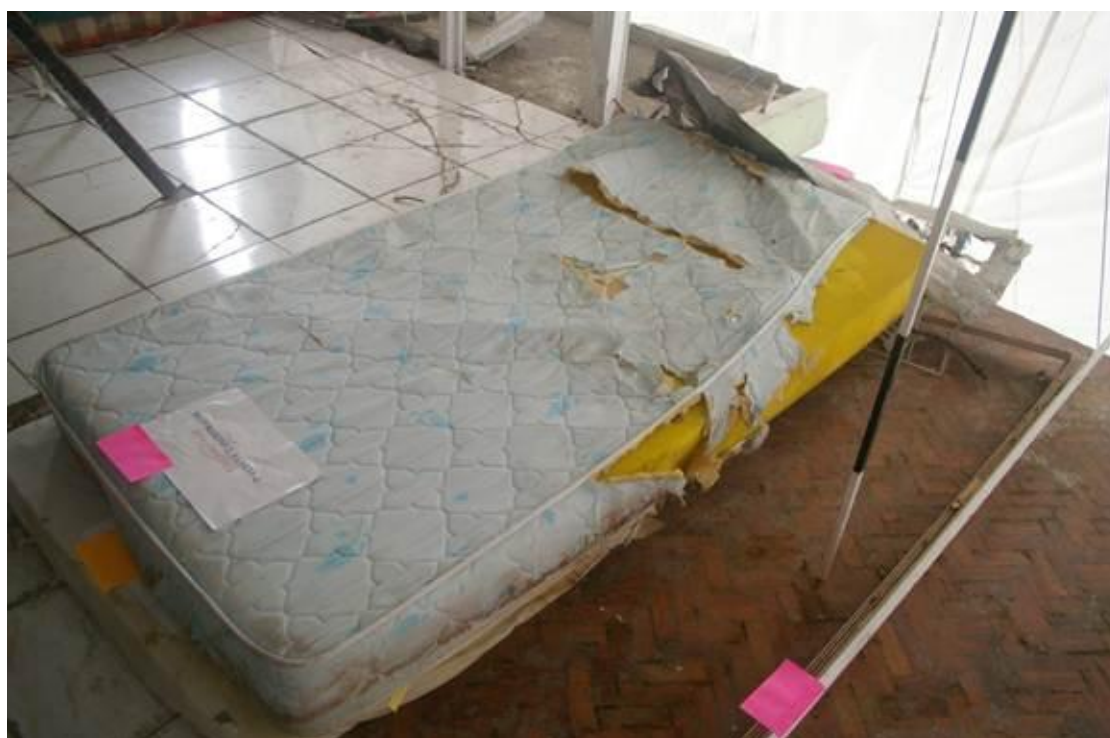
Figure 22 – heat damage to bed in bedroom 2;

note top mattress position reversed, more severe heat damage should be at South end

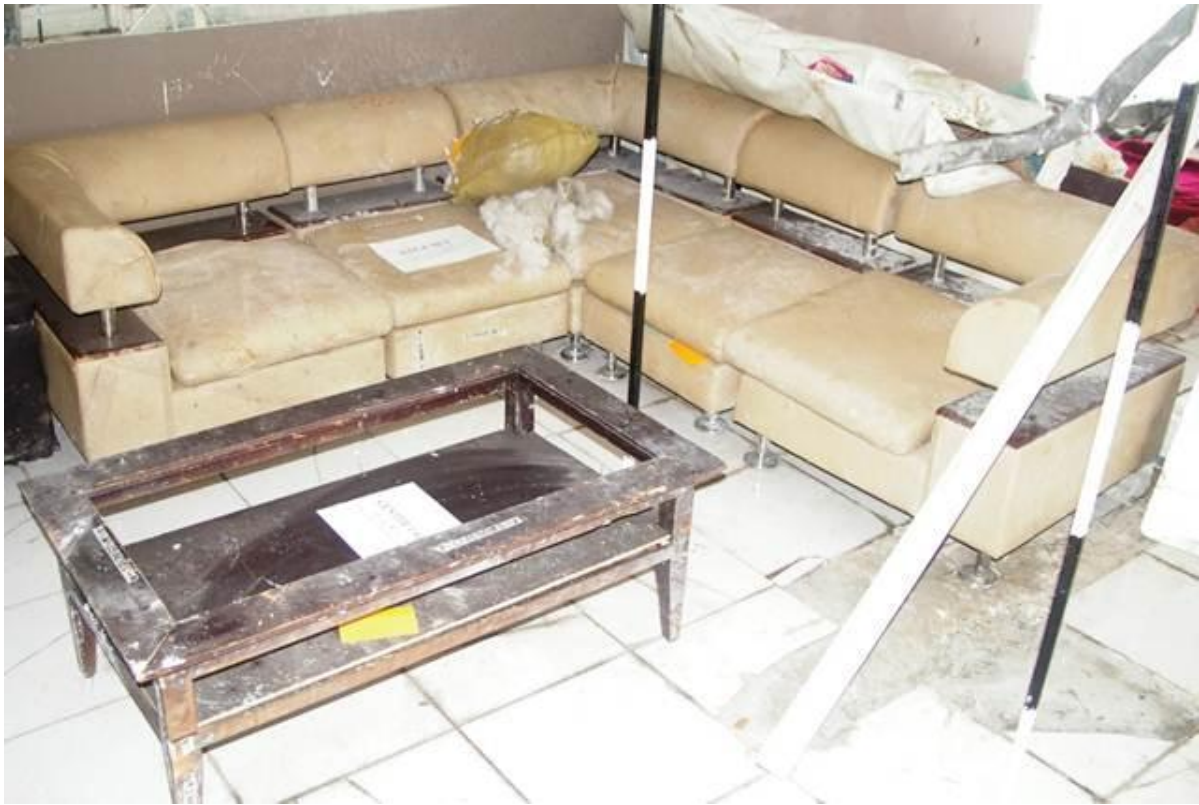
Figure 23 – melting and scorching to front faces of sofa cushions, scatter cushions penetrated

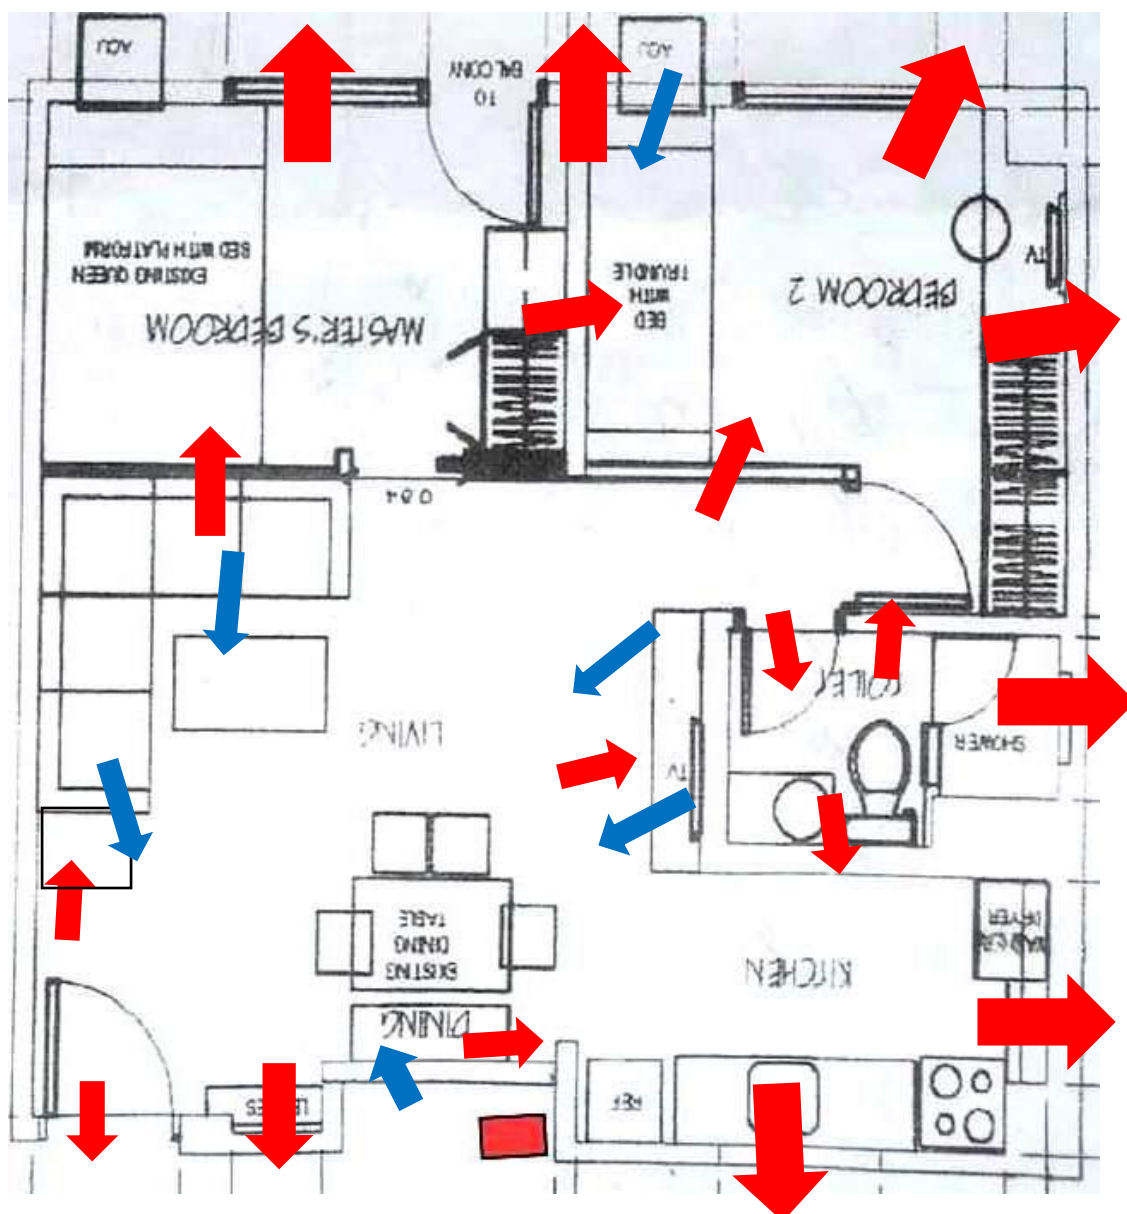
50. The pressure vectors were plotted on a floor plan to assist in locating the explosion epicentre. Figure 24 below shows a simplified version of the vector plot for clarity.

Figure 24 – simplified pressure vector plot of Unit 501B,
superimposed on C+G Design Studio concept plan

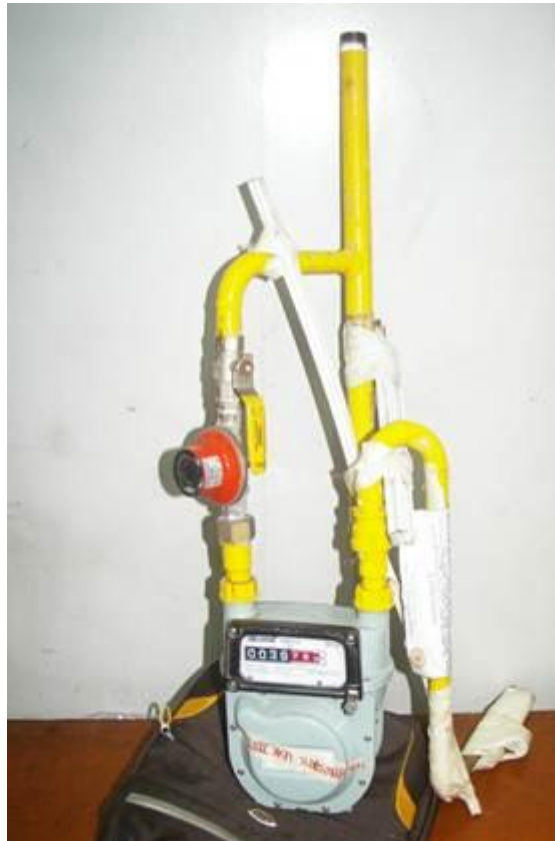
52. The gas meter was removed complete with the supply pipe, manual ball valve and regulator from the cupboard outside 501B. It bore evidence identification labels confirming this information. The pipework had been unscrewed at its threaded joints.
53. The ball valve was in the ON position, with the handle parallel to the pipe, and the meter and regulator were intact with no observable heat or impact damage. The regulator was marked as shown below. The meter reading showed 39.797 cubic metres, as previously recorded by SOCO personnel. The supply pipe was labelled 'tested no leak 6/22/10'.

Figure 25 – gas meter and pipes from 501B

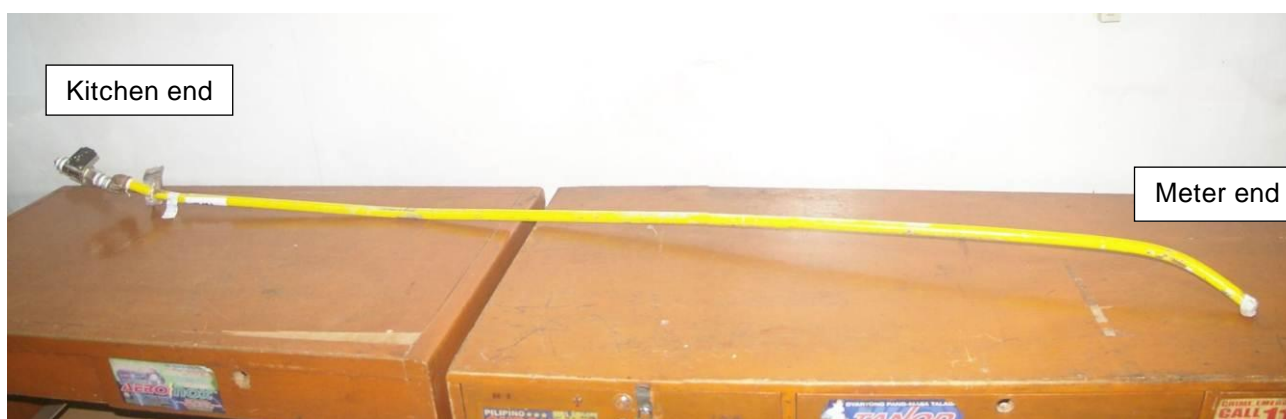
54. The stub-out pipe was approximately 2.5m long, with two shallow bends and a double elbow connection at the kitchen end (furthest from the meter). Attached to the second elbow was an impact damaged electrical shut-off valve with a chromed outlet, into which was screwed a brass flexible hose fitting.

Figure 27 – stub-out pipe
