Serendra Explosion Incident

Final Report – Part One

The Incident, Its Origin and Immediate Cause

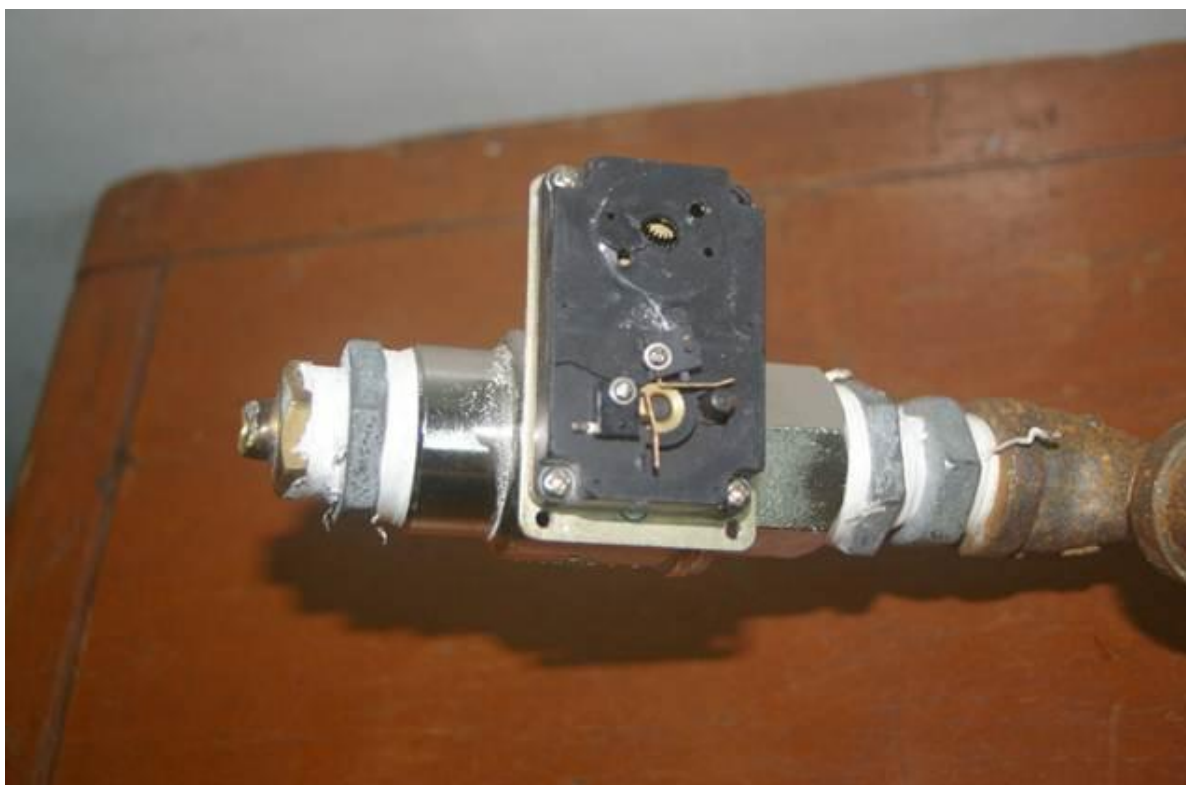
Figure 28 – stub-out elbow coupling to damaged shut-off valve

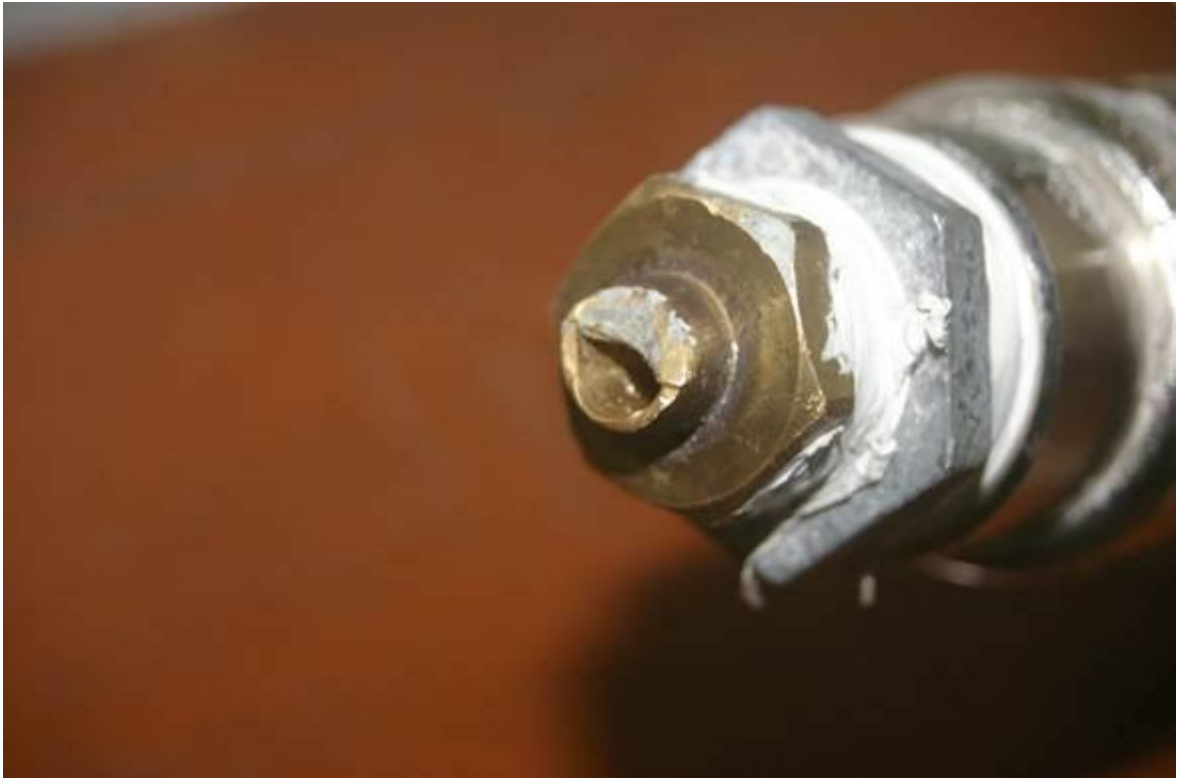
55. The fitting was sheared off with a fractured surface, indicating a violent impact or distortion but not repeated flexing. On the chromed surface were abrasions and adhering material consistent with an impact. There was a metal clamp and bracket attached to the kitchen end of the pipe, of the type used to hold it to a wall or the inside of a cabinet. The bracket was also broken with a fractured surface.

Figure 29 – fractured end of flexible hose fitting

63. At the other end, the hose was firmly clamped around a broken brass fitting which corresponded to the remains in the stub-out valve outlet (see Figure 29).

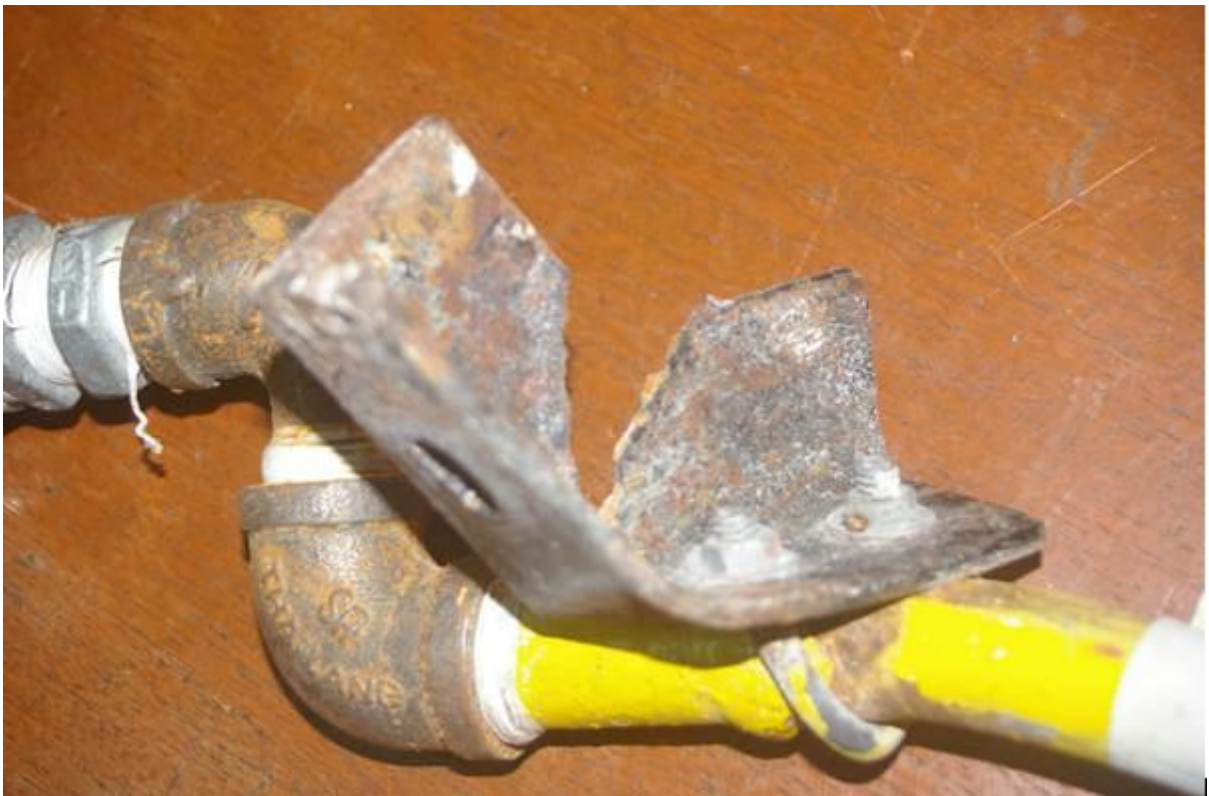
Figure 30 – pipe clamp and bracket

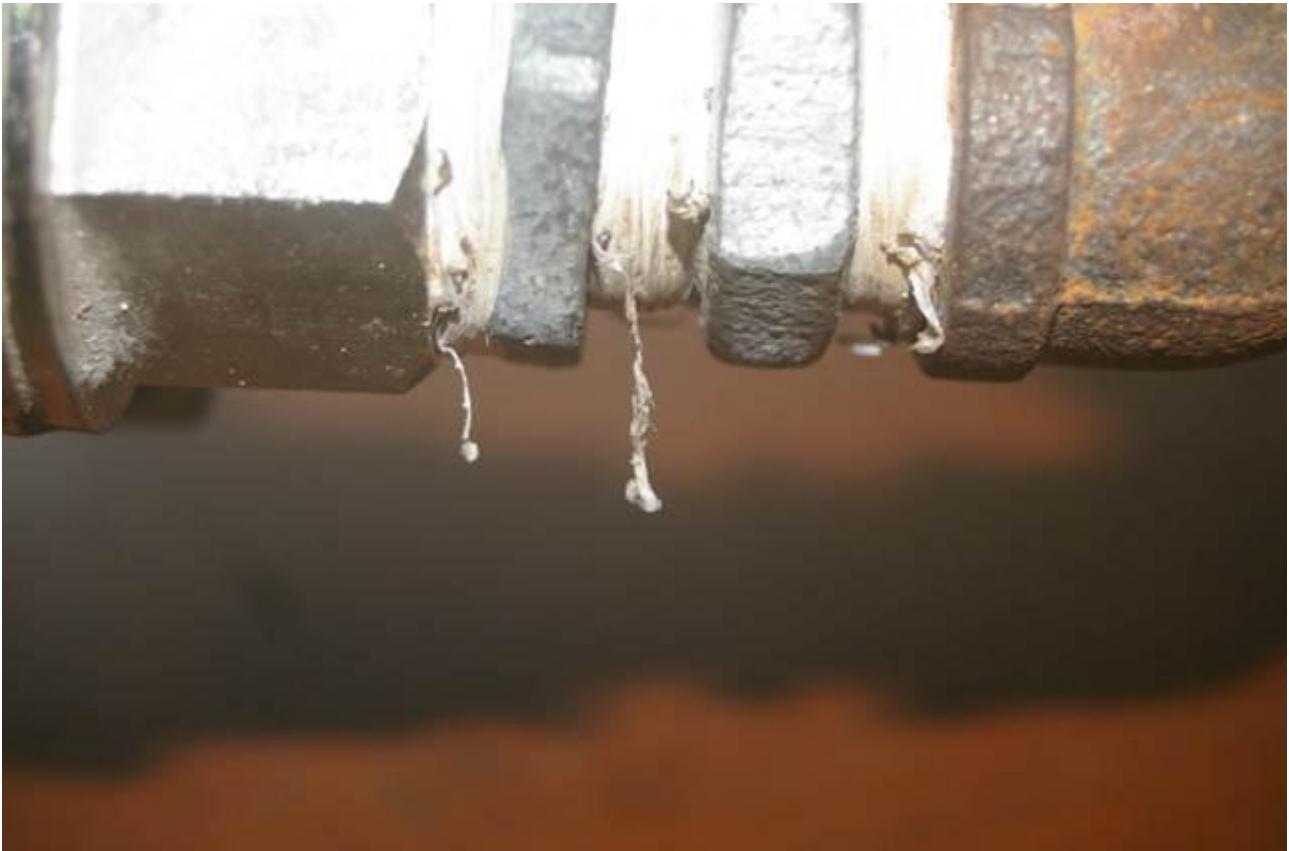
56. The fittings were installed with white PTFE thread tape, protruding ends of which were shrivelled and scorched by transient flame contact. This was the visually the same type of tape as that used in the meter cupboard.

Figure 31 – close view of heat-affected thread tape

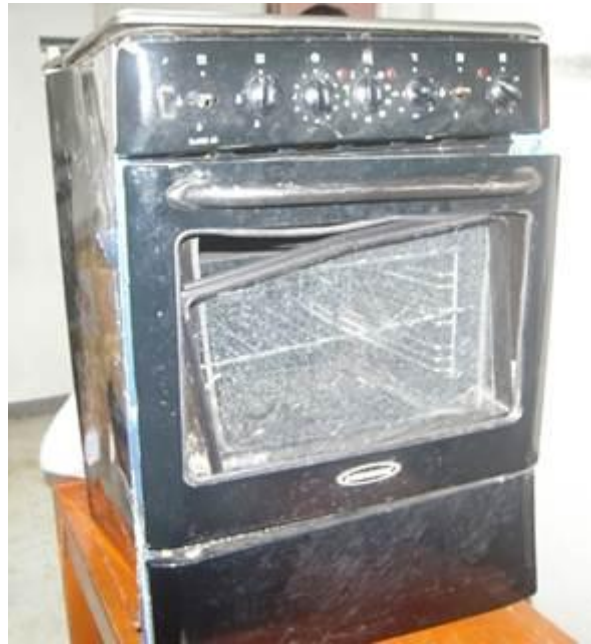
57. The range was a black-finished 'La Germania' model SL6031 60BT, serial number 0403-A-0588. It was equipped with three gas hob burners, one electric hotplate, and an electric oven-grill combination. The oven showed no indication of having been used and the hob drip tray was very clean. The range gave the impression of being either newly installed or very little used prior to the incident.

Figure 32 – kitchen range front

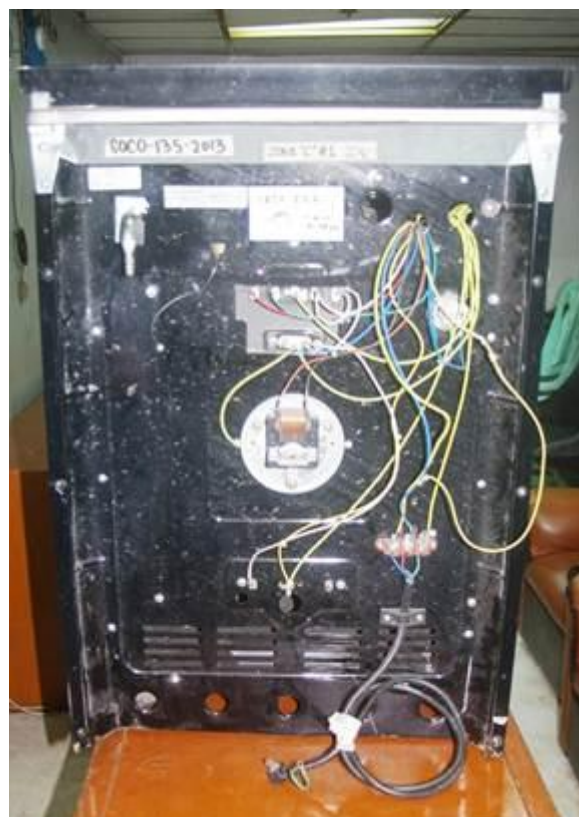
58. There was an electrical input at the rear which terminated in a two-pin plug with a separate earth tail. The prongs of the plug were distorted, suggesting they were pulled laterally from the socket. The range had not been hard-wired into the kitchen supply circuit as is common for appliances of this type in many countries. Other electrical connections at the rear supplied the hotplate, oven and grill heating elements and the oven fan. Some of the spade terminals were displaced but there was no indication of electrical arcing or melting at any of the contact faces.

Figure 33 – kitchen range rear

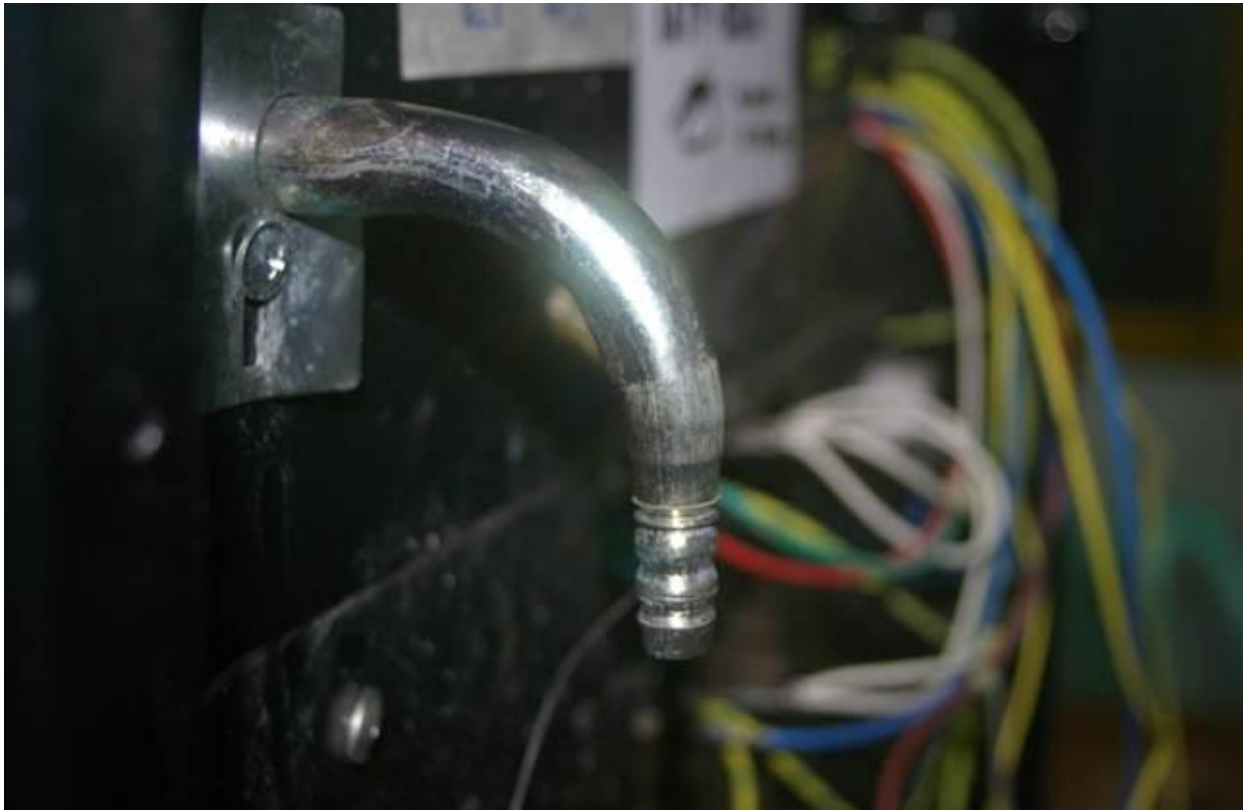
59. The gas burner and oven-grill controls were all in the OFF position, as shown by the spindle flats where two of the control knobs were missing. The electric hotplate control was in the ON-LO position with no indication that this was due to impact. However it could have been moved during retrieval; the position of this knob at the time of discovery is not clear in the SOCO-NBI photographs.
60. At the rear of the range, the gas inlet fitting was intact and undamaged by bending or impact. It was located behind the rear right of the hob (viewed from the front of the appliance) and designed to accept a flexible hose with clamp fitting.

Figure 34 – gas range inlet fitting

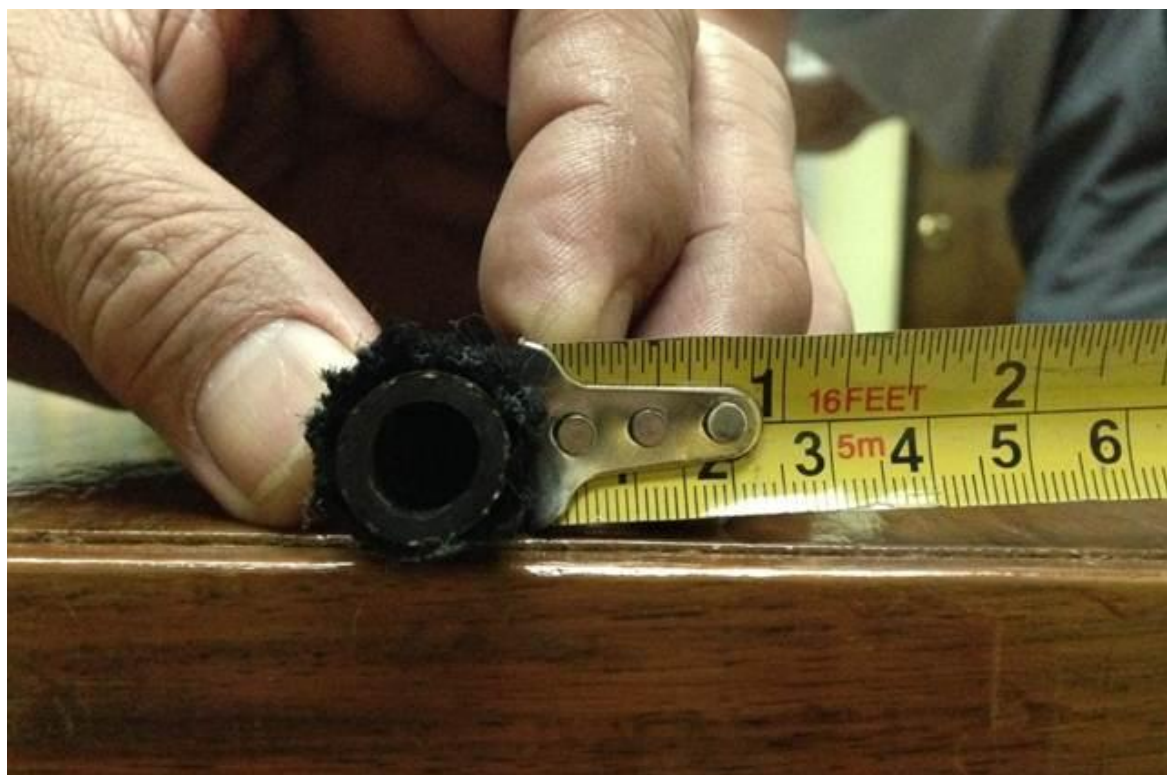
Figure 36 – open end of hose

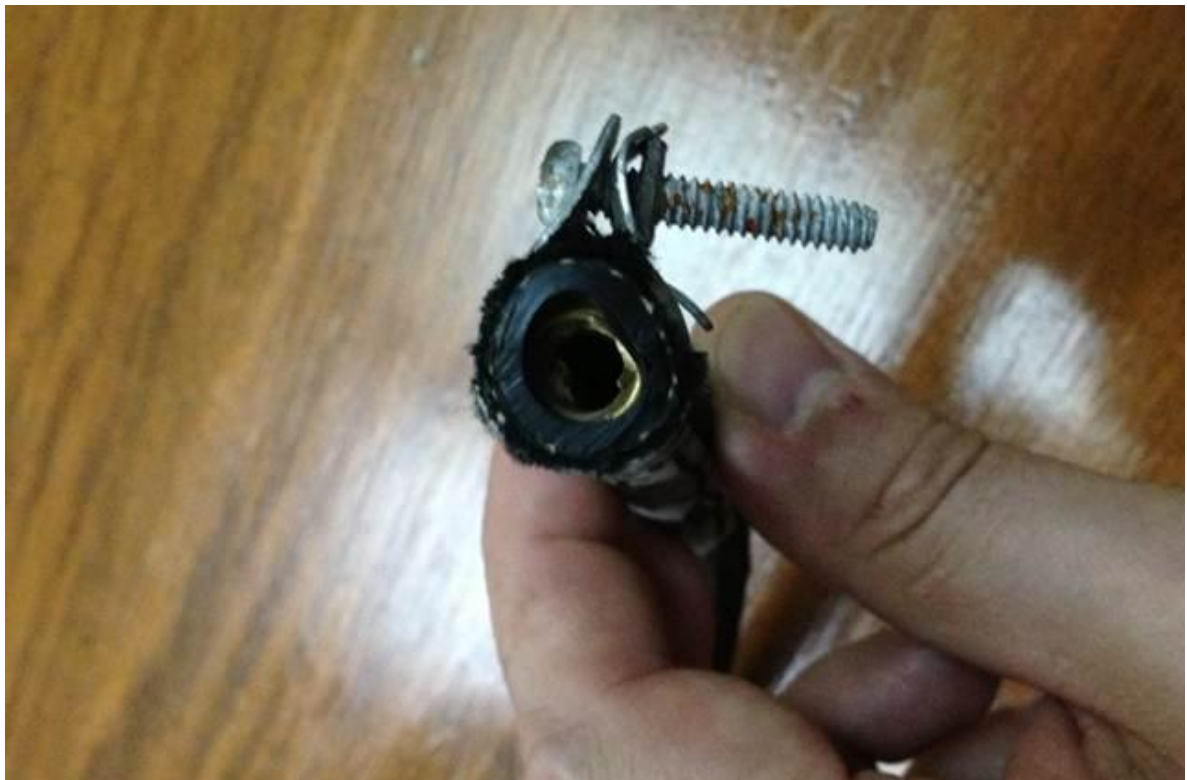
Figure 38 – remains of brass fitting in clamped end

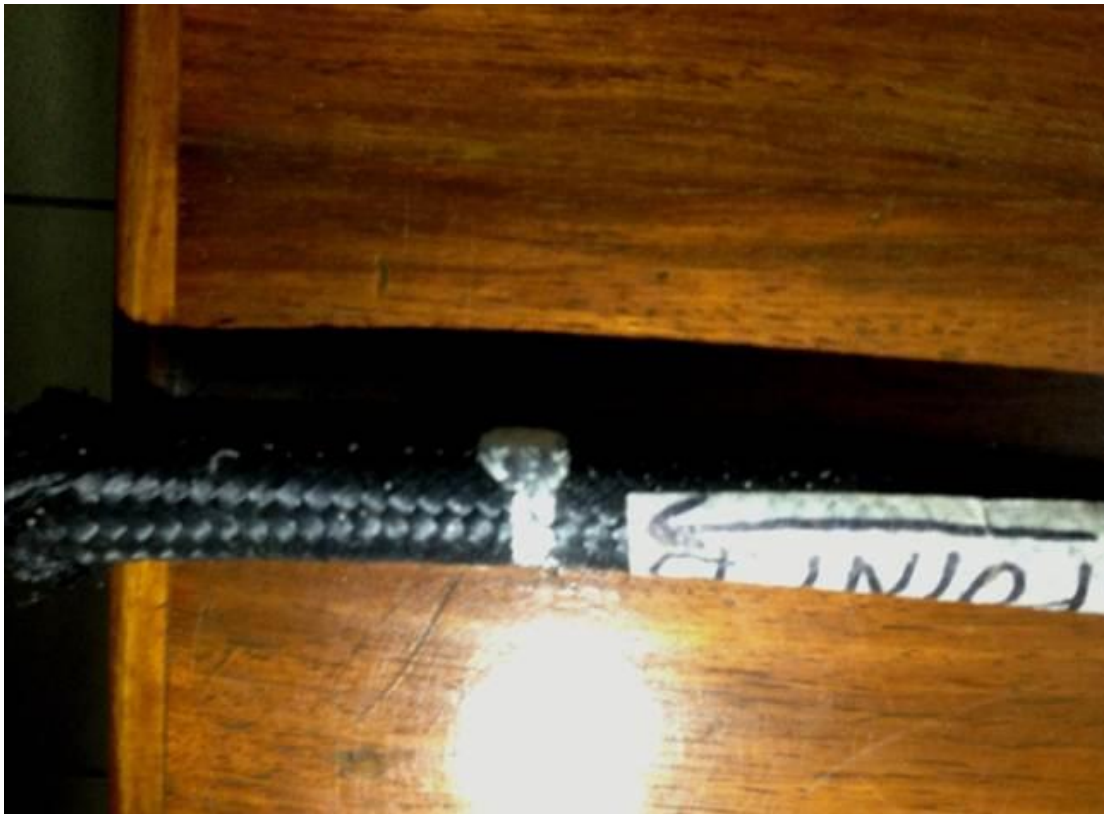
64. Approximately 50mm from the open end was a drip mark resembling white paint. The directional nature of this, perpendicular to the pipe axis, indicated that it had been deposited while the pipe was horizontal. When attached to the range, this section of hose would be close to vertical.
65. Approximately 300mm from the open end was a screw clamp which had been taped in position when recovered. The screw fitting was loose, such that the clamp would slide on the hose unless taped.

Figure 39 – paint drip near open end of hose

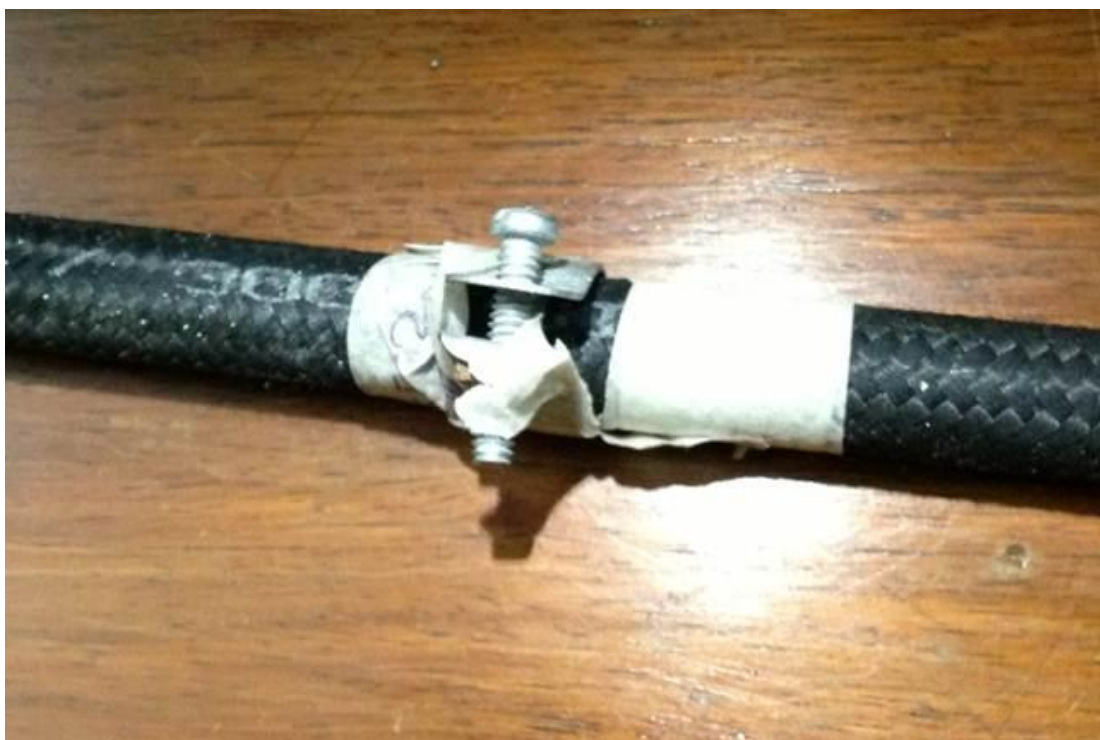
Figure 40 – loose clamp 300mm from open end

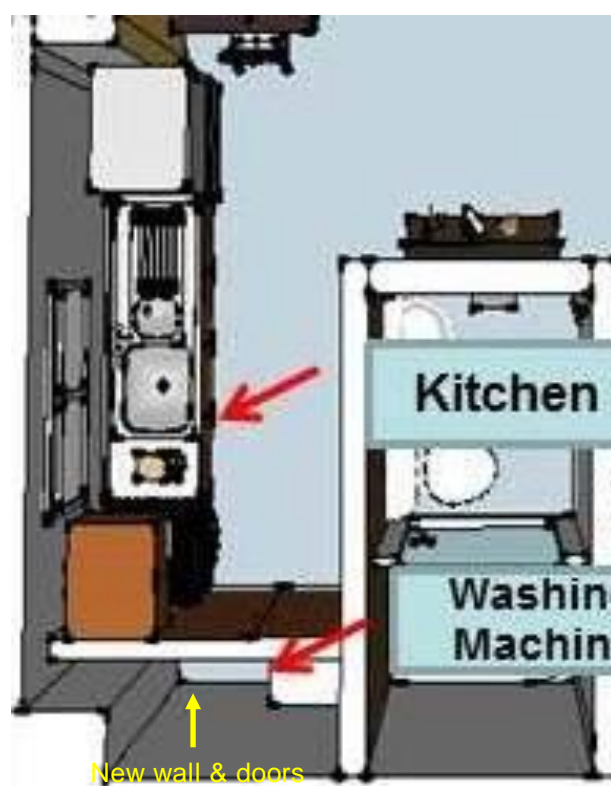
10. Comparison of the physical remains and dimensions of the under-sink cabinet with those fitted in other comparable units showed inescapably that it had been shortened at the east end. Whether this was done at the time of this renovation or previously could not be firmly established. However, there would have been no reason for this to occur when the range was in its former position abutting the corner column.

Figure 46 – post-renovation layout,
as deduced from evidence
(Not to scale – for illustration only)

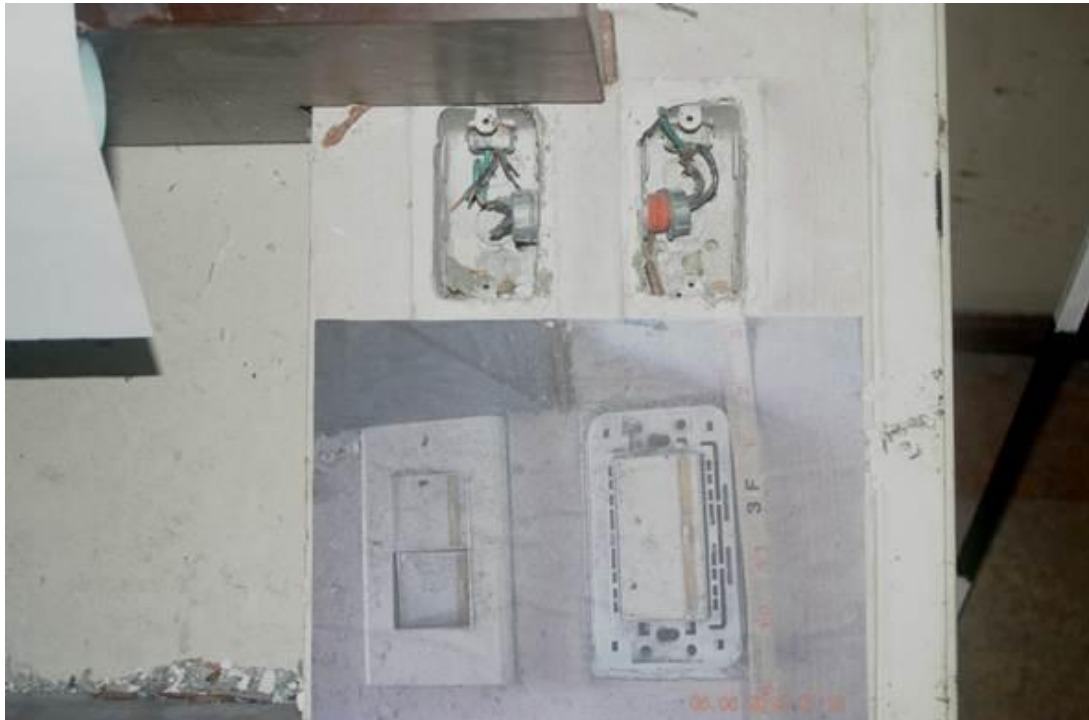
21. The brief description Mr San Juan was able to give to Mrs Ochoa before hospitalisation indicates that he was at or close to the unit door at the time of ignition. Immediately beside the door were two electrical switches, one for the lights and the other a main power override switch. On laboratory testing, the latter was found to be in the OFF position.

Figure 47 – original location of switches beside door,
with photograph of positions as found after explosion
