**INTER AGENCY ANTI-ARSON TASK FORCE**

**SUBJECT : Fact Finding - re: The Explosion/Fire at Unit 501B**  
**(4th Floor Level), Section B Tower A, Two Serendra,**  
**McKinley Parkway Drive, Bonifacio Global City,**  
**Taguig City, last 7:59 PM, 31 May 2013.**

**DATE : 14 August 2013**

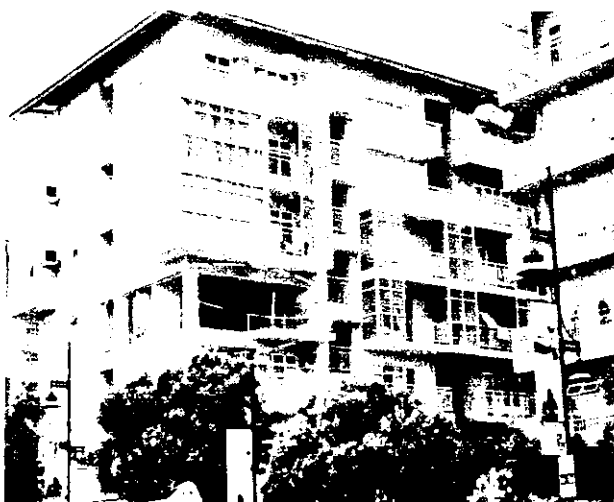
Fig.9 The exterior view of Section B Tower A, where the "spraycrete" walls of Unit 501B (encircled) was, before the explosion propelled it to the North and East directions.

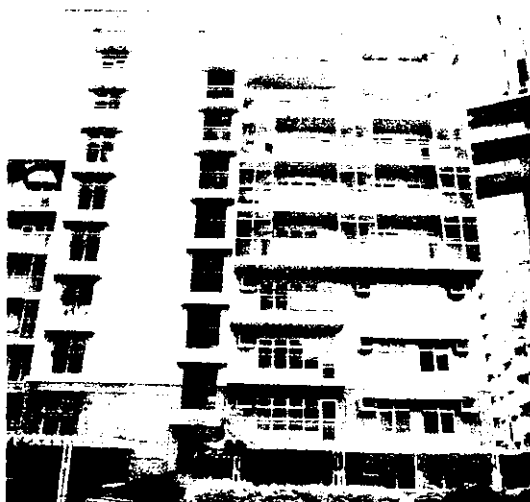
Fig.10 Showed the exterior view of Section B Tower B, rear portion also damaged by the explosion.

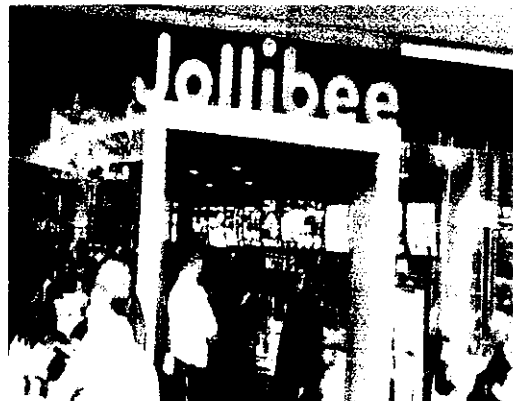
Fig.14 Showed the Jolibee hit by the BPF located approximately 179m from unit 501B. (Farthest distance reached by the BPF).

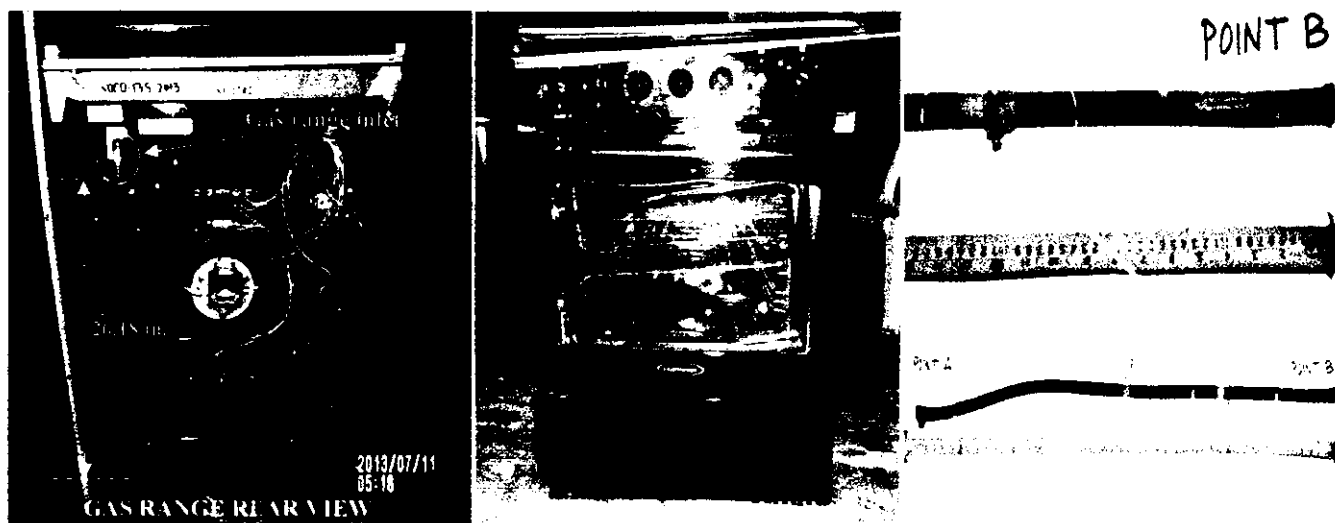
4. That the gas discharge computation and actual simulation are consistent that the leak came from a 9mm opening, which is the inner diameter of black braided flexible hose, and this could be done only if the said hose is totally disconnected from the La Germania LPG gas range when the gas valve was opened in the morning of May 31, 2013.

Fig.27 showed left photo, the gas range inlet location at the back portion of gas range and its height to the floor at 26 inches. Photo in the middle showed the front view of the gas range. Lower Right Photo showed the color black braided flexible hose and Upper Right photo showed Point B is for gas inlet connection, where the clamp (encircled) is loosened and located 31cm to point B, indicating that it was pulled down and hose not connected to the gas range inlet prior to blast.

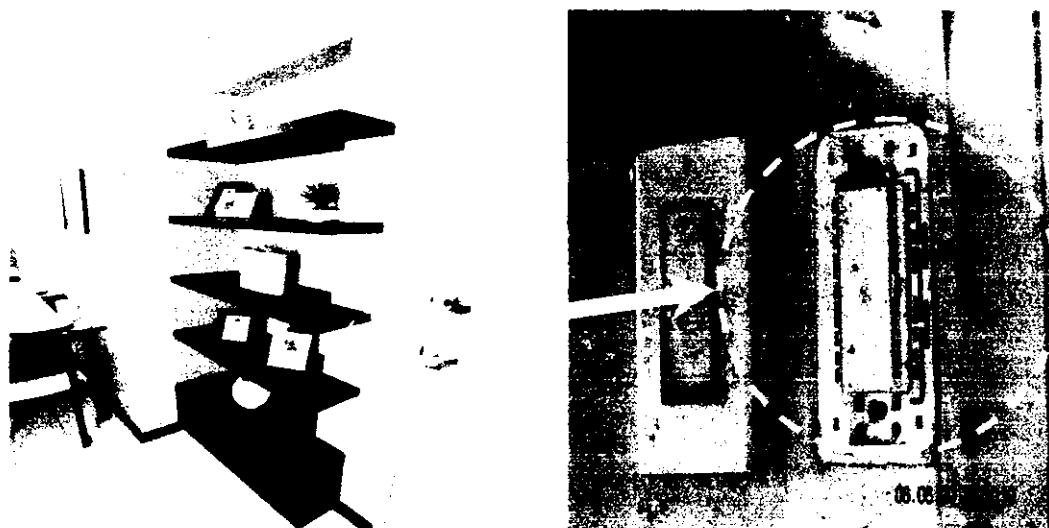
Fig.28 Showed the portion of the South wall near the main door prior to explosion (left photo) where the single and duplex switch was installed. Close-up photo (right) of the light switch taken after the blast, while the single switch (encircled at right photo) was probably the one that triggered the explosion when it was turned-off by Angelito San Juan.

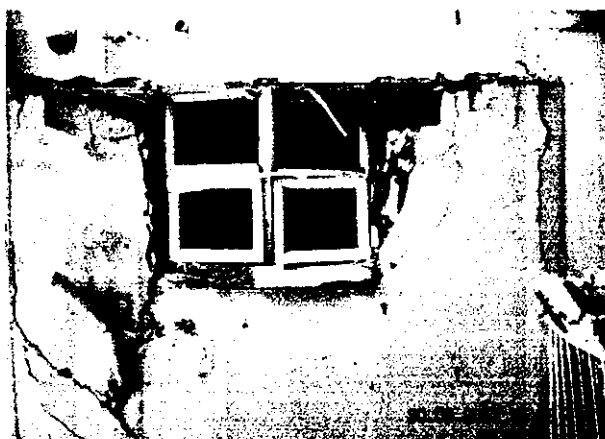
4. The **BPF** that moved in this direction towards Unit 502B and toppled part of the wall and rested on the wall of 502B at an angle of 46.5 degrees. Further as the southside wall toppled it severed the metal door jam of Unit 501B, while the main wooden door was shattered into several pieces and landed on the hallway fronting it. The **BPF** also blasted the other portion of the southside wall particularly at the kitchen area blasting it and hitting the outer side of the kitchen wall of 502B kitchen (Fig. 34). The **BPF** also pushed the Gas range, the flexilble hose, range hood, Kitchen Sink and housing and Refrigerator out of the kitchen area and all fell to the ground near Unit 101B.

Fig.34 showed the wall with window of the kitchen area of Unit 502B.

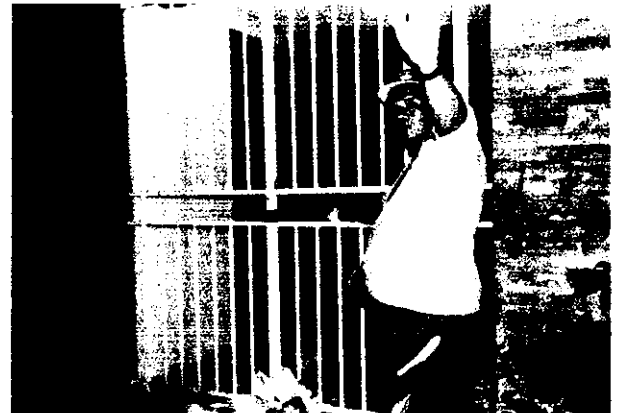
Fig.42 SRSUPT FVJAUDIAN tracing the BPF effect at the area at Tower AI that damaged the elevator doors from the GF 2nd 3rd and 7th Floors of Tower AI

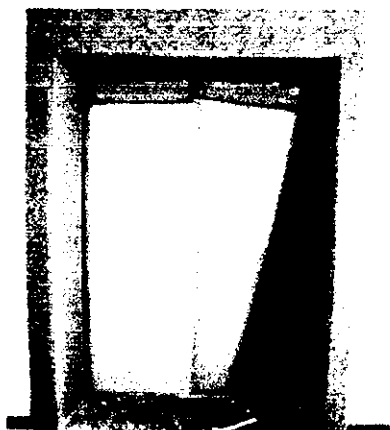
Fig.49 Showed Elevator 1 where the BPF dislodged the door and entered the shaft

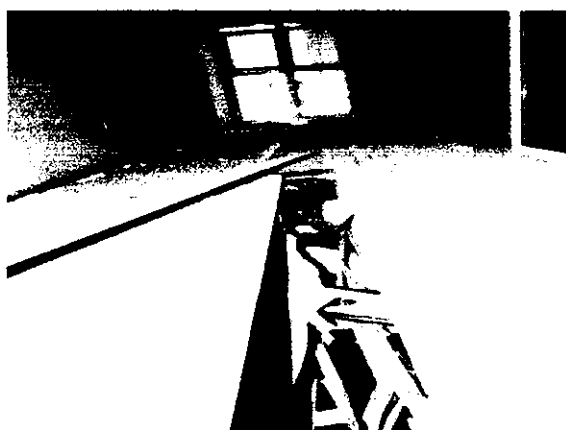
Fig. 54 showed the damaged seismic gap cover assembly was dislodged probably caused by the Positive Pressure Phase of the explosion.

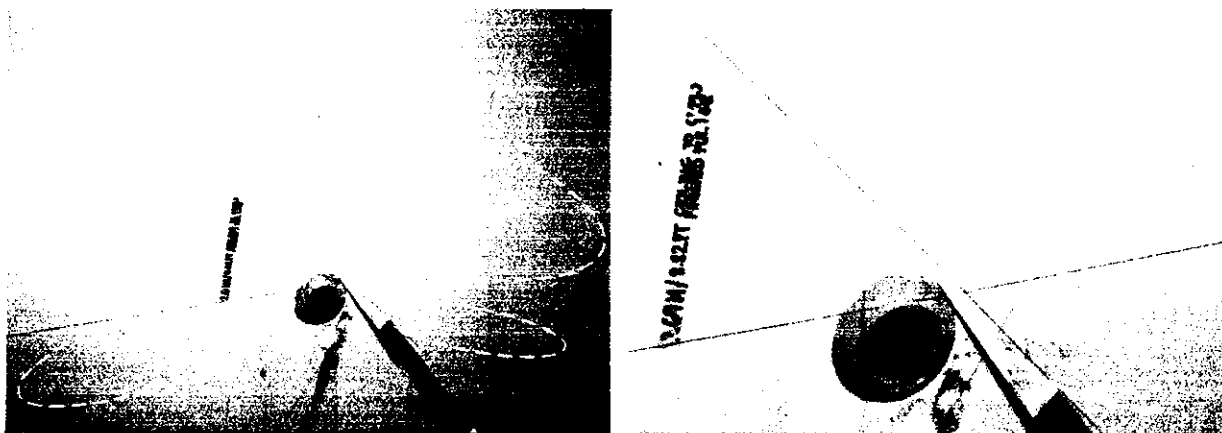
Fig.60 Cracks (encircled) at the ceiling of Unit 501B caused by the blast. Right photo is the close-up view of said cracks.

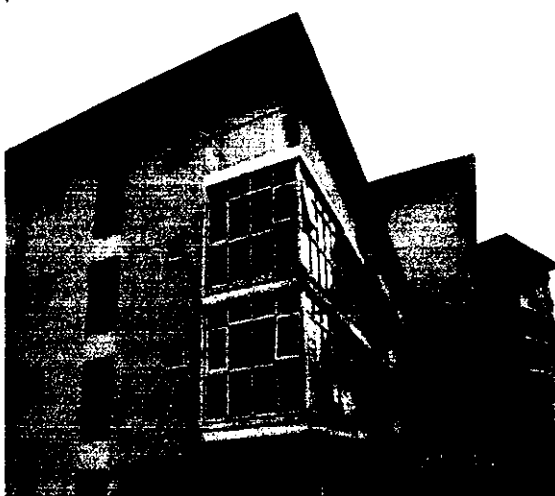
Fig. 65 showed the ceiling eaves of Tower BA damaged by the BPF that vented downward in this area.

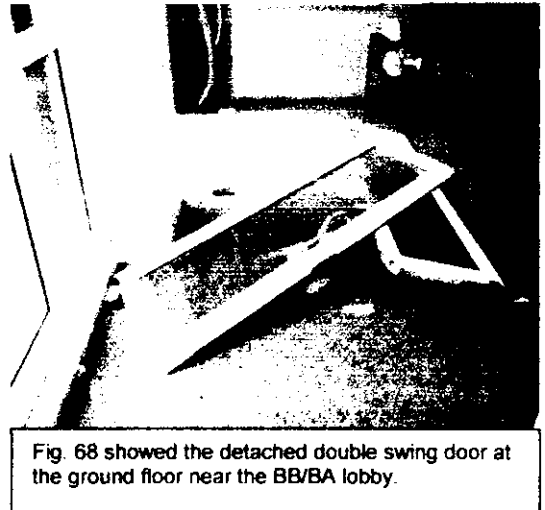
Fig. 68 showed the detached double swing door at the ground floor near the BB/BA lobby.

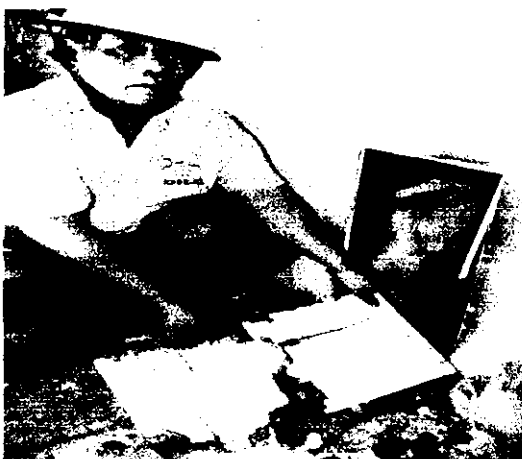
Fig.76 Showed the LPG meter chase of Unit 506B with sign of burning and soot. No sign of burning at the door chase, indicating that it was propelled first during explosion then the fire ensued.

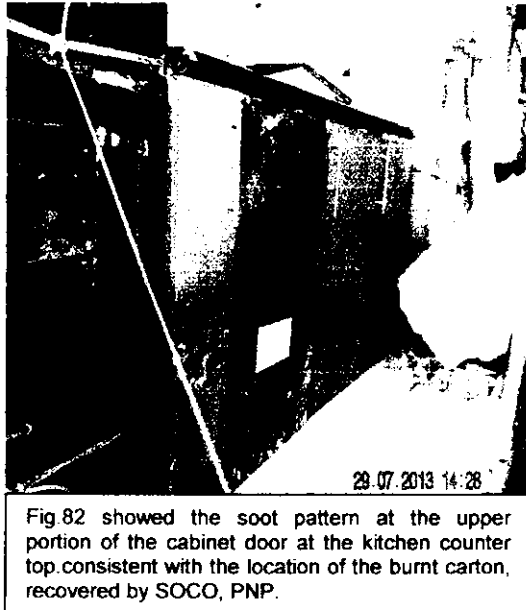
Fig.82 showed the soot pattern at the upper portion of the cabinet door at the kitchen counter top consistent with the location of the burnt carton, recovered by SOCO, PNP.

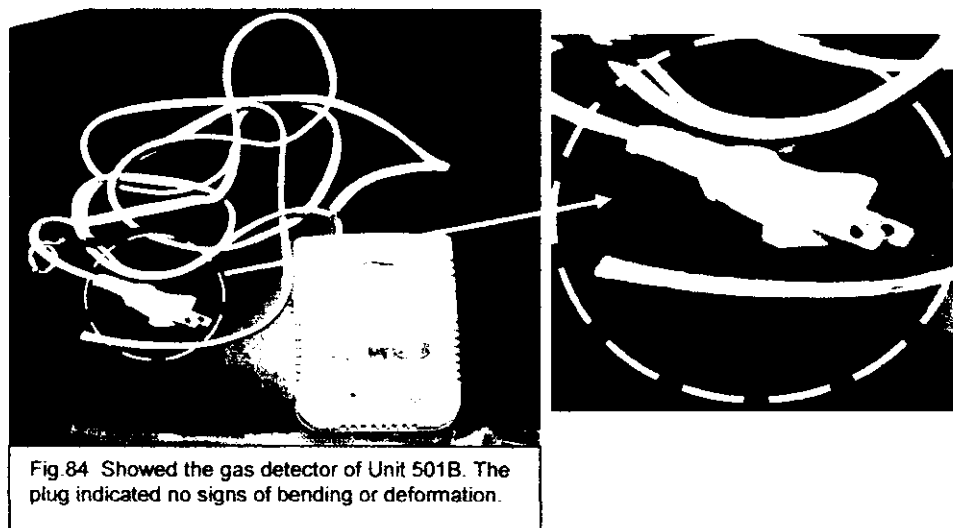
Fig 84. Showed the gas detector of Unit 501B. The plug indicated no signs of bending or deformation.
