Serendra Explosion Incident

Final Report – Part One

The Incident, Its Origin and Immediate Cause

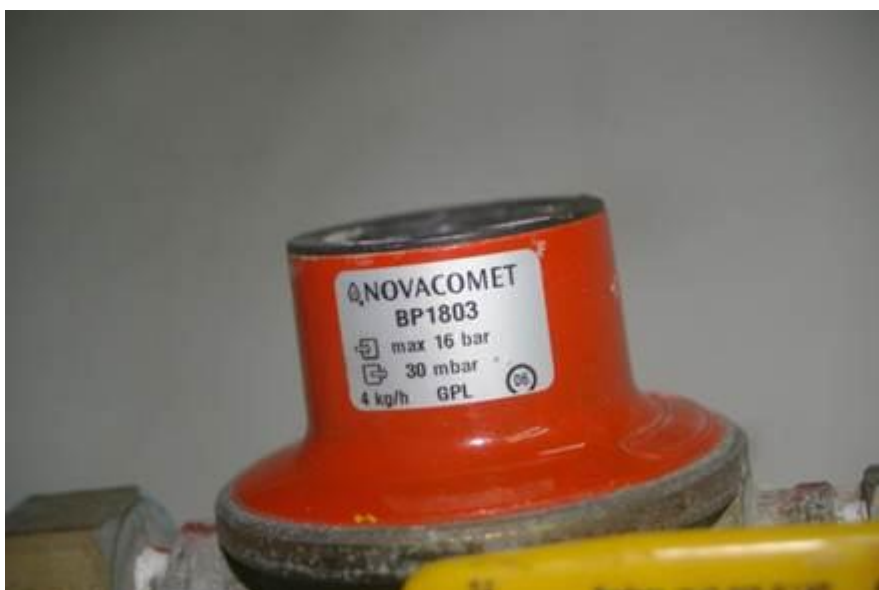
Figure 26 – regulator markings

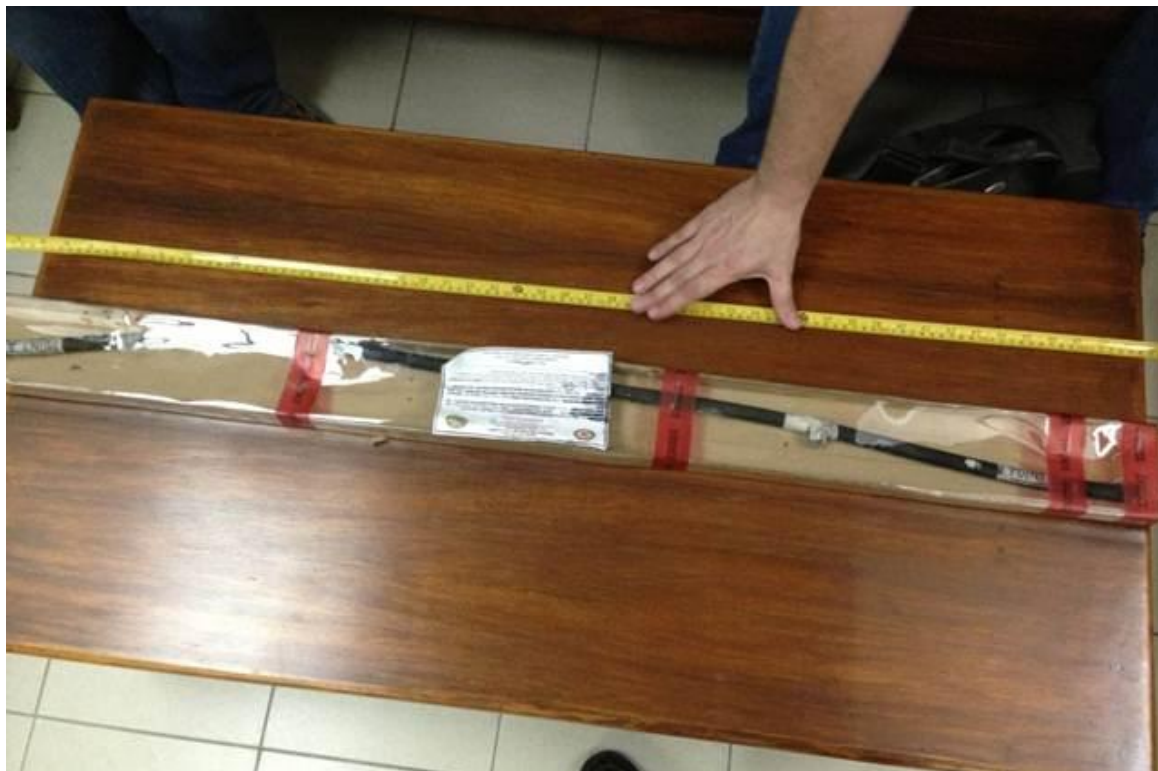
Figure 35 – flexible hose in packaging

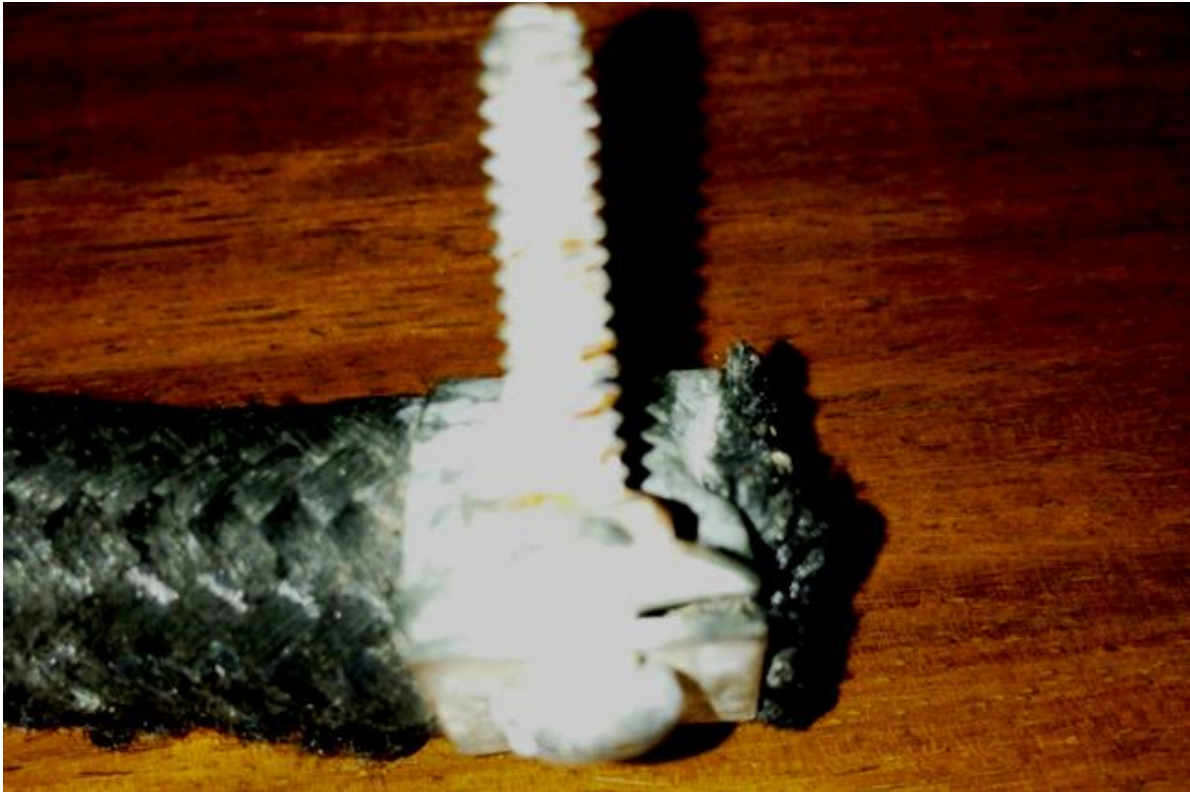
63. At the other end, the hose was firmly clamped around a broken brass fitting which corresponded to the remains in the stub-out valve outlet (see Figure 29).

Figure 37 – clamped end of hose

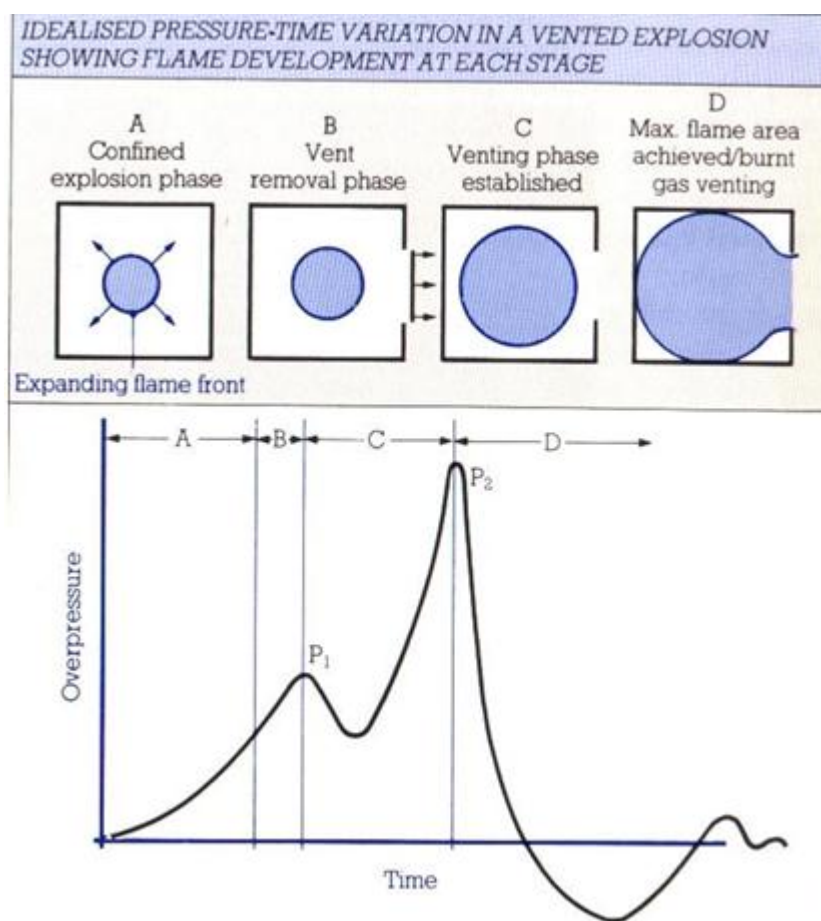
12. The type of explosion resulting is known as a 'vented confined explosion', where parts of the structure fail in order of weakness to vent the pressure. If the vent area is insufficient the pressure continues to build until another structural element fails, and so on. This can result in multiple peak pressures, each higher than the previous one.

Figure 42 - simplified stages of a vented confined gas explosion²

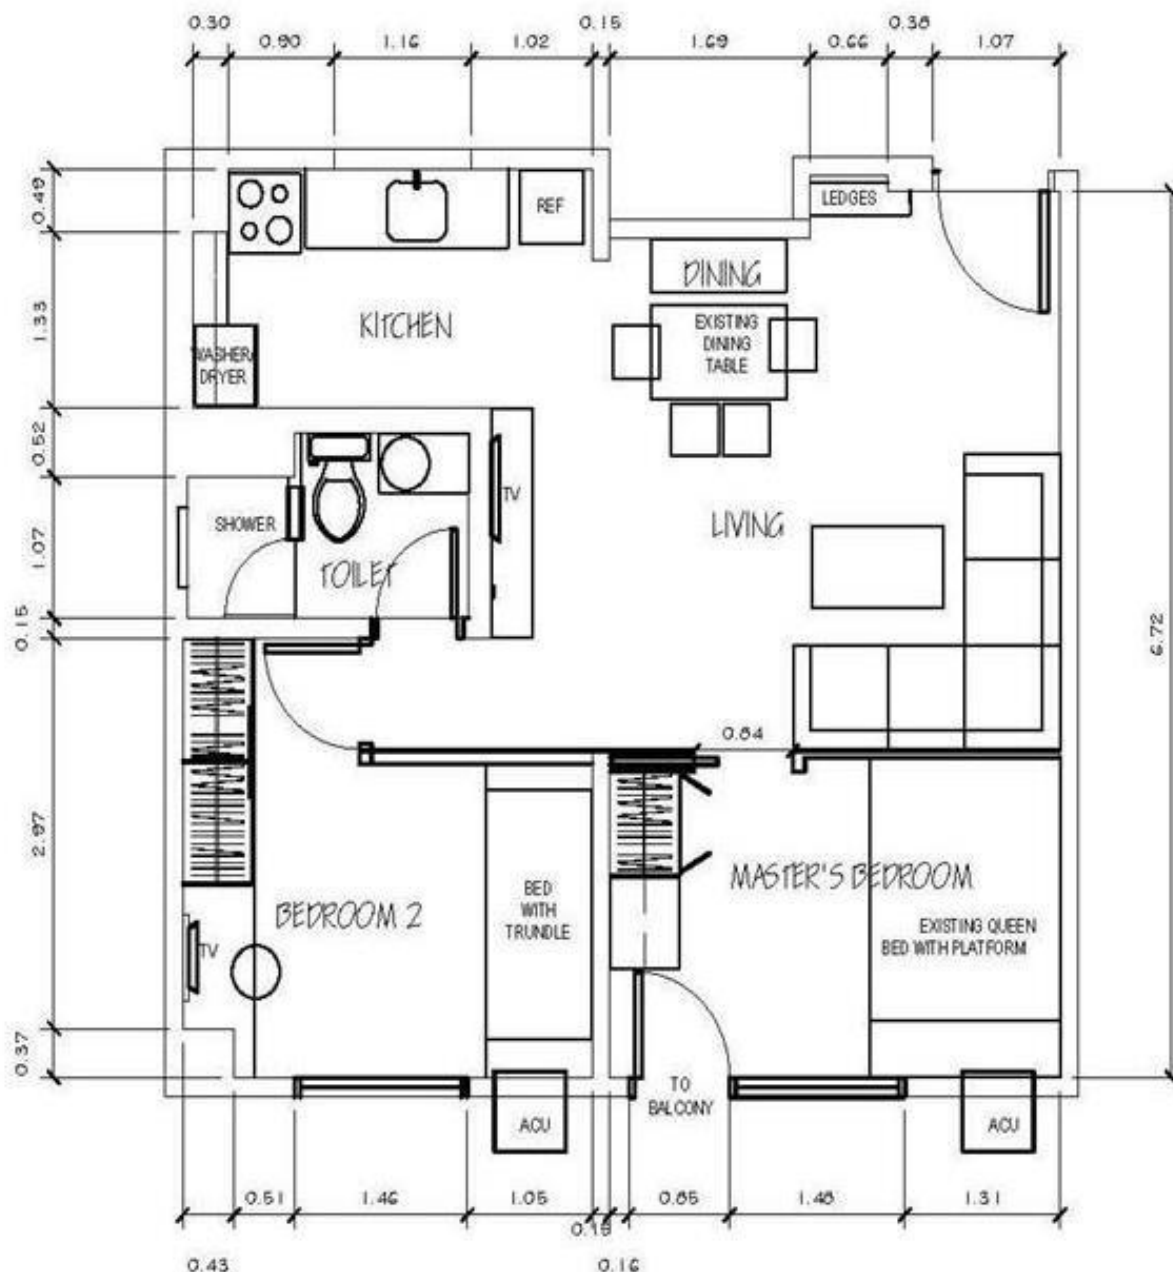
8. The design concept did not include any remodelling of the kitchen stove and sink area, as the intention was to locate the washing machine in the north-east corner of the kitchen outside the existing closet arrangement. This is shown in the concept plan reproduced below.
9. However it is not reflected in the Scope of Works under 'Architectural Works' which includes the phrase 'Kitchen-Washer/dryer cabinet'. From photographs taken after the renovation and the recreated layout derived from physical evidence, it was seen that a new wall section and doors were positioned west of the column forming the south-east corner of the kitchen. This would be necessary to make an enclosure deep enough for the washer/dryer. Thus it shortened the room and required the under-sink cabinet to be modified to allow the range to fit into the reduced space at the south-east corner of the kitchen.

Figure 43 – C+G Design Studio concept plan
(Not to scale – for illustration only)

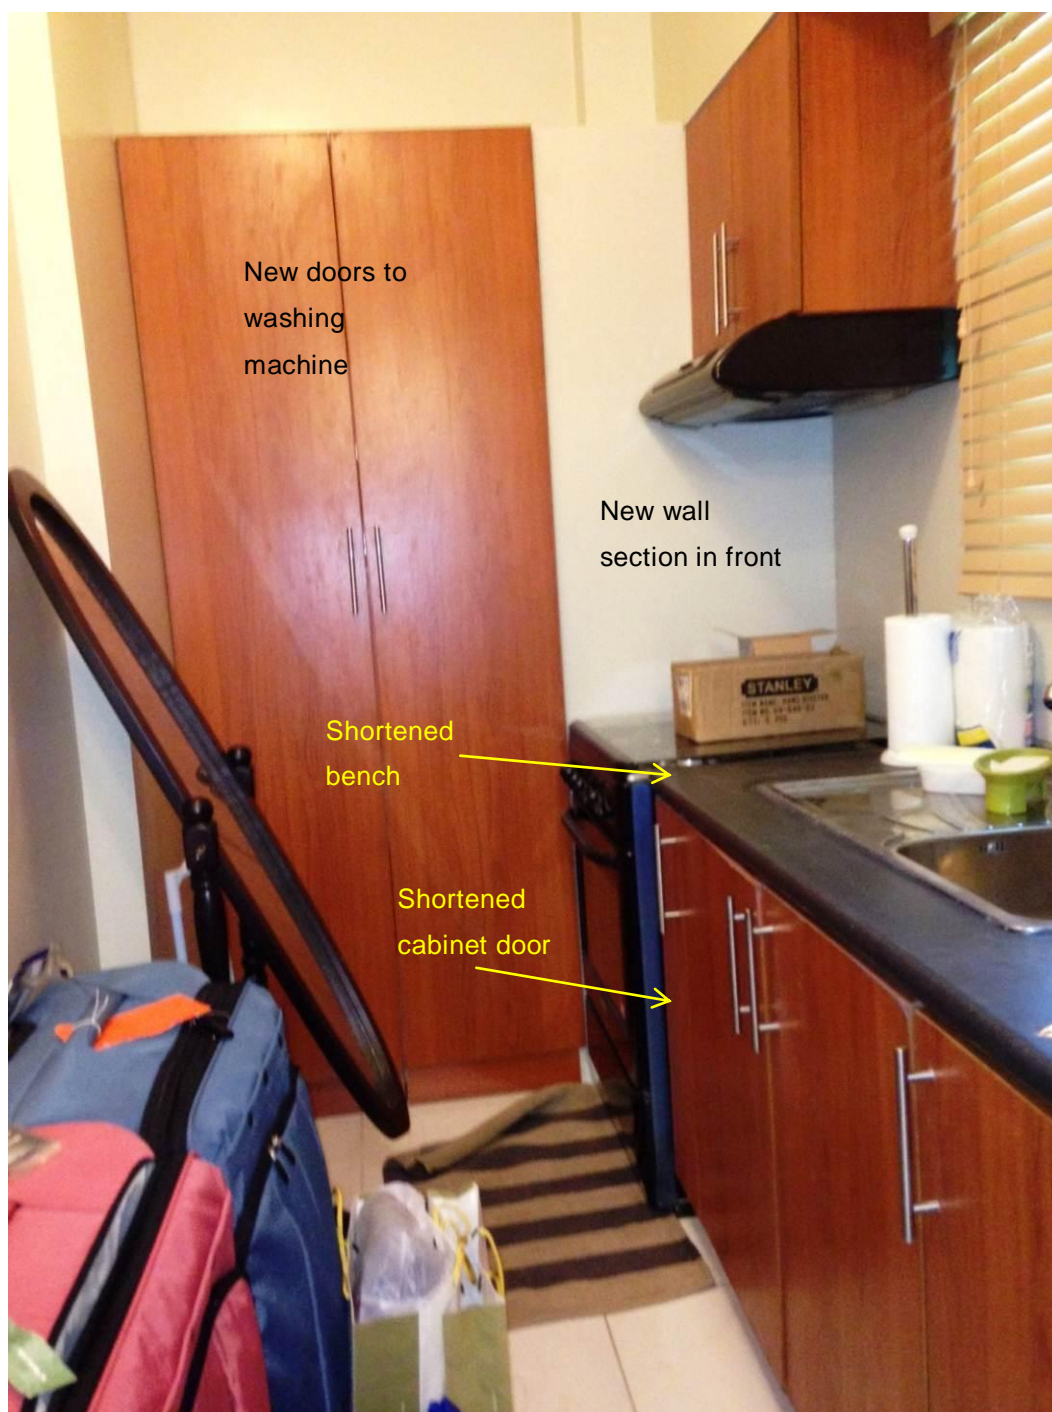
Figure 44 – post-renovation kitchen layout,
photograph provided by Ms Cayton with annotations by Kroll

10. Comparison of the physical remains and dimensions of the under-sink cabinet with those fitted in other comparable units showed inescapably that it had been shortened at the east end. Whether this was done at the time of this renovation or previously could not be firmly established. However, there would have been no reason for this to occur when the range was in its former position abutting the corner column.

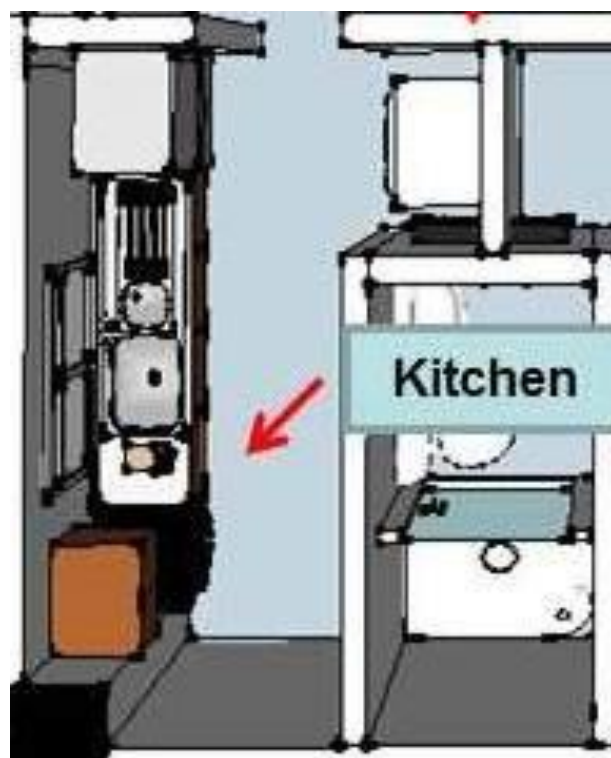
Figure 45 – pre-renovation layout
(Not to scale – for illustration only)
