**INTER AGENCY ANTI-ARSON TASK FORCE**

**SUBJECT : Fact Finding - re: The Explosion/Fire at Unit 501B**  
**(4th Floor Level), Section B Tower A, Two Serendra,**  
**McKinley Parkway Drive, Bonifacio Global City,**  
**Taguig City, last 7:59 PM, 31 May 2013.**

**DATE : 14 August 2013**

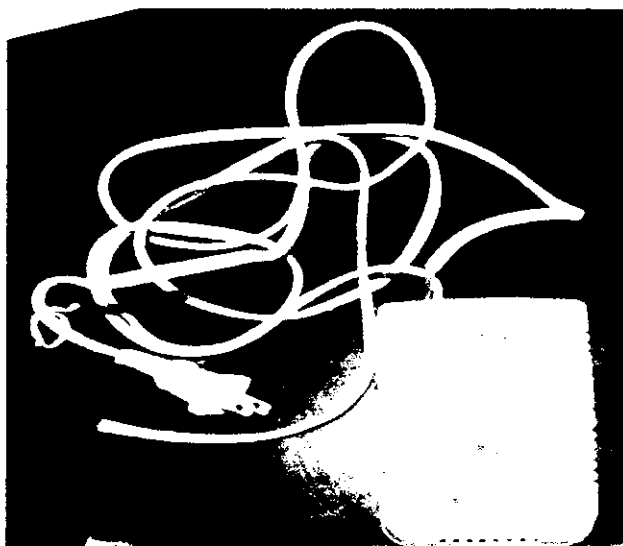
Fig.7 showed the Gas Leak Detector (Home Alert brand) of Unit 501B recovered by PNP after the explosion and turned-over to IATF-CT.

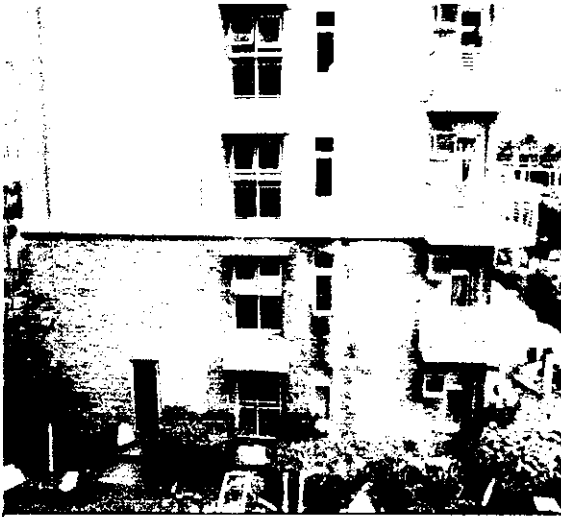
Fig.11 The exterior view of Section A Tower I, facing Section B Tower A.

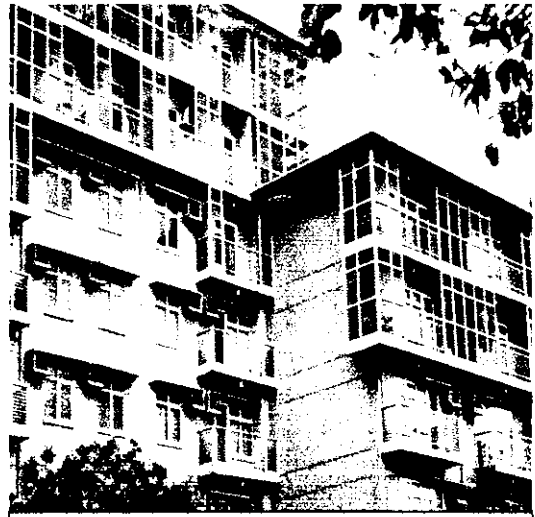
Fig.12 The exterior view of Section A Tower H facing McKinley Parkway Drive.

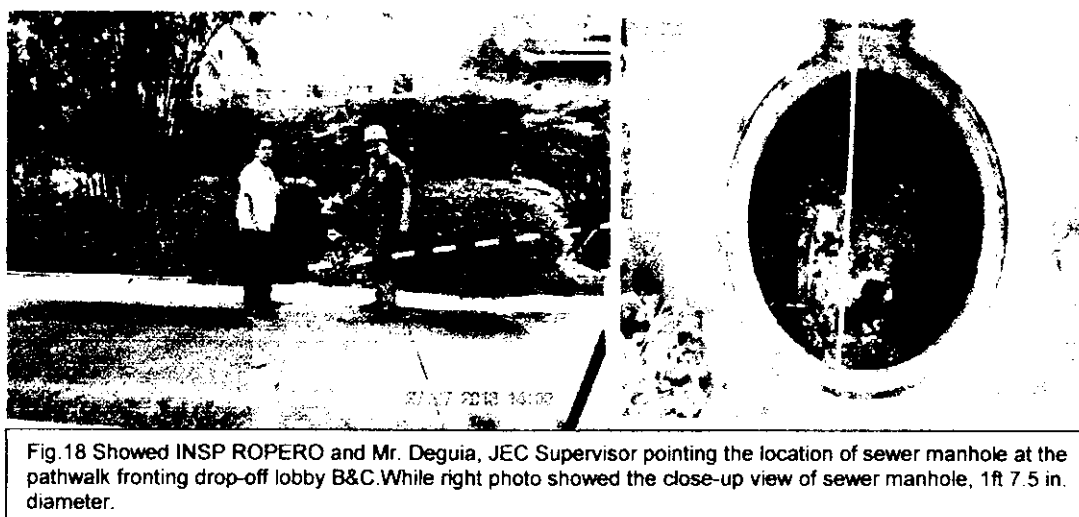
Ocular inspection conducted, we were able to trace the location of the sewer manhole where the human waste goes, which is located outside the building, approximately 49 meters from Tower BA. The location of the sewer manhole is in an open air and far apart from Tower BA and could not possibly accumulate methane at the said tower. (See figure 18)

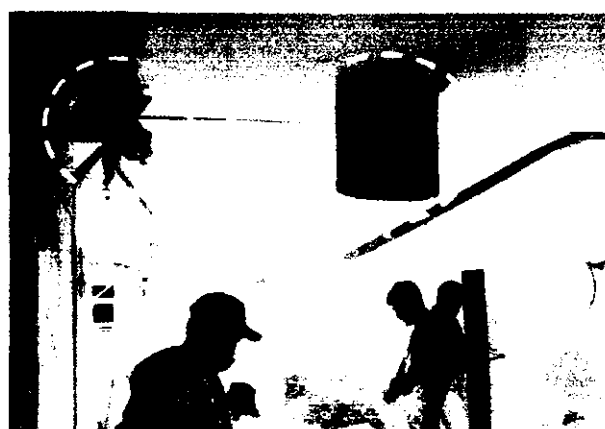
3. From the source of ignition - as the blast pressure propagates it pushed upwards the seat cushion of the sala set and the thermal heat effect singed the leatherette casing causing it to melt and as it hit the ceiling it stuck together with the throw pillows (Fig 33). (Theoretical Maximum Flame Temperature for Butane: 3583 °F, Propane: 3573 °F - Ref: Explosion Investigation and Analysis, Patrick M Kennedy, John Kennedy, righted 1990, p. 419 )

Fig.33 Show SOCO,PNP, processing Unit 501B - the sala set cushion (encircled right) and throw pillows (encircled left) stuck at the ceiling after the blast.

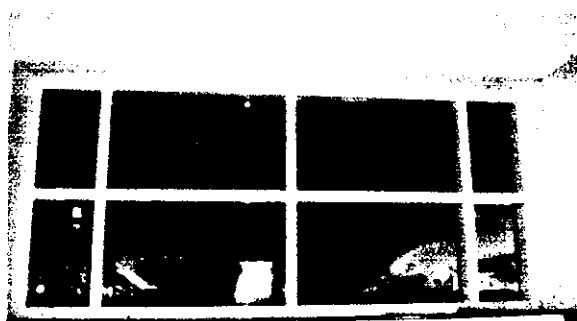
6. The BPF continued and damaged the exterior ceiling (Fig.37) portion of the Function Room No. 2. The BPF also reached the drop-off lobby of Section Belize and Gallery where it was recorded by the CCTV installed thereat. Later, during the **Negative Phase** the pressure hit the Fire Cabinet (made of metal) pushed it 2 inches more inward from its original depth of 7 inches in the direction towards the epicenter of the explosion (Fig. 73).

Fig.37 showed the exterior ceiling of Function Room No.2 Section B&C, utilized as Crisis Management Center and later IATF Command Post.

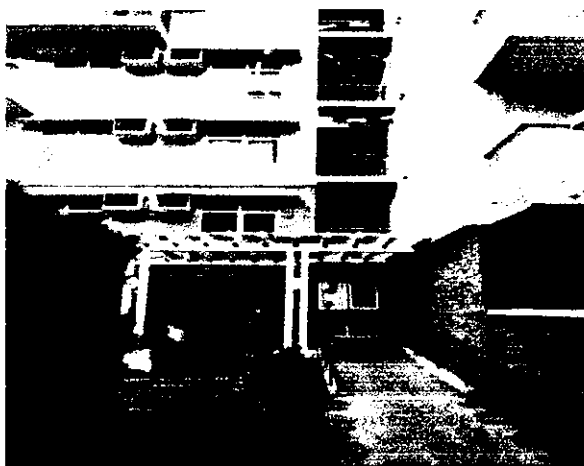
f. 1. Left direction and vented (to the South direction - exited the building towards the South (Fig. 46). At this juncture, eyewitness RAMIL ARSOLA heard the explosion and saw the fire at 5th floor of Section B Tower A, alarmed he immediately run towards the drop-off lobby of Belize and Callery, at McKinley Parkway Drive, and got hold of a fire extinguisher and responded to the subject building, but upon

Fig.46 Showed the hallway (encircled) where the BPF exited.

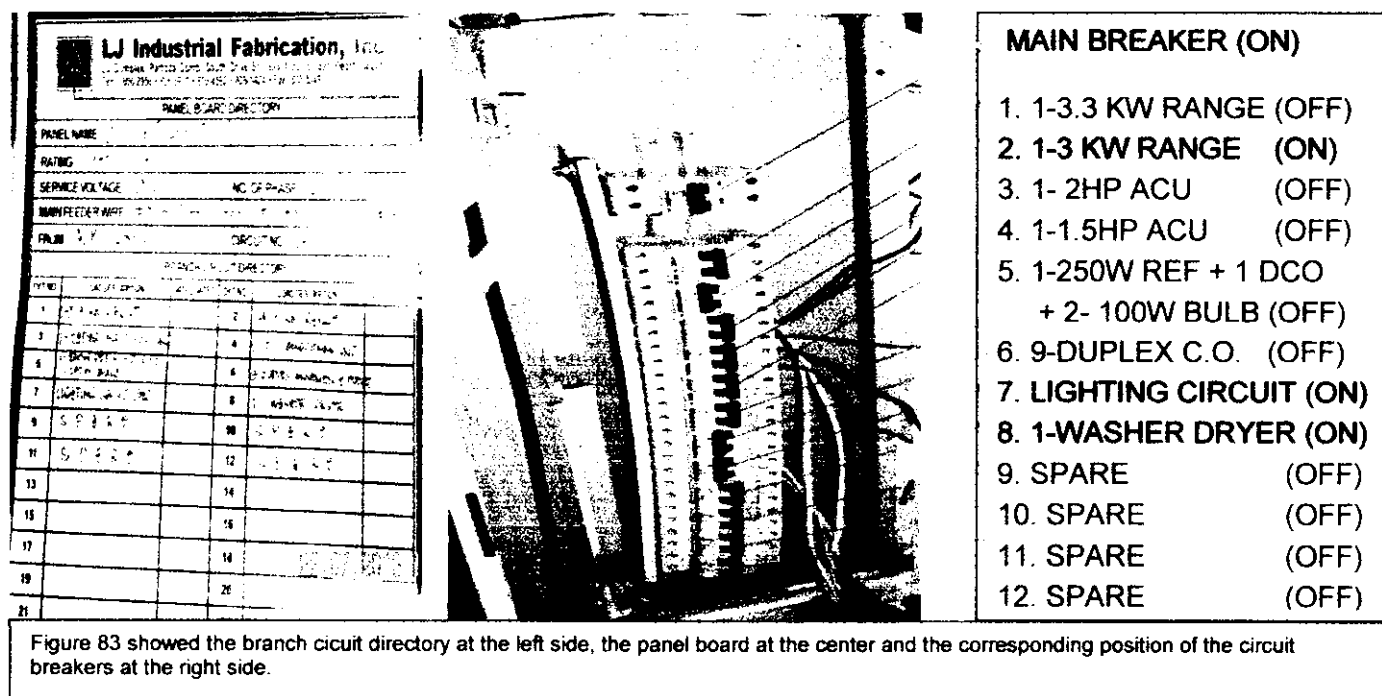
The electrical panel recovered at Unit 501B which was also submitted to NBI Electrical Division marked as Evidence # 33. The electrical panel has the following branch circuit directory number and corresponding designated load and circuit breaker position (whether on or off) as shown in Figure 83.

The position of the circuit breakers are consistent also to the findings of ENGR. DAVID AONAN, Chief Electrical Section, NBI in his Electrical Report # 13-06-002 dated 18 June 2013 that, "Main circuit breaker is in the **"ON"** position. There were no wires connected to the said breaker. Circuit breakers # 1, 3, 4, 5, 6, 9, 10, 11 & 12 are in the **"OFF"** position. No traces of short circuit in any of the wires connected to the said breakers. Circuit breakers # 2, 7, & 8 are in the **"ON"** position. There were no wires connected to the said breaker."

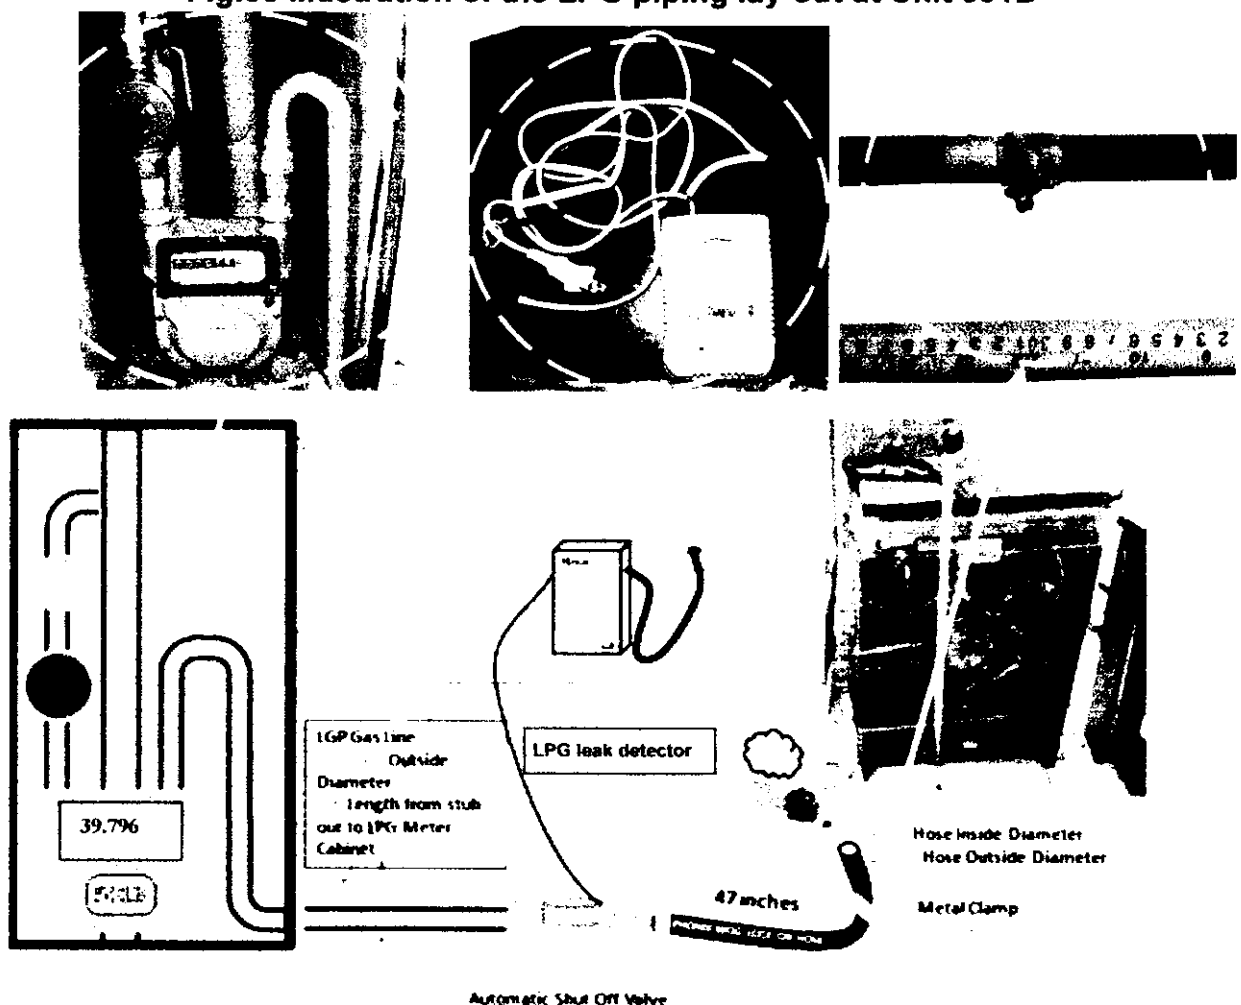
**Fig.85 Illustration of the LPG piping lay-out at Unit 501B**

When the LPG supply was turned-on at around 7:00AM by Ariel Mendez, the gas detector did not sound an alarm nor did they (Herminia Ochoa, Alicia Mendez, Ariel Mendez, Arlean Mendez) smelled the LPG discharging from the 9mm diameter braided flexible hose. The LPG accumulated inside unit 501B unnoticed and undetected, even at around 7:55 PM minutes before the explosion when Herminia Ochoa, Secutiy Guard Falcasantos and Security Officer Arsola knocked the door of Unit 501B to fetch San Juan. Thus, we believed that the gas detector was not connected at the convenience outlet during the explosion as it did not show any bending or deformation/damage despite the fact that it was thrown outside the unit. Likewise, the circuit breaker for gas detector was in "off" position rendering it unoperational. While the LPG gas leak detector located at 101B Section B Tower A chase did not activate an indication that the involved fuel was only confined to the subject unit, thus, it did not enter the chase and reach said detector. (See fig. 85)

Note: Photo on the upper left showed the LPG Meter reading that stopped after the explosion, at the upper center showed the Gas Leak Detector with the male plug intact with no signs of damage or bending, a clear indication that it was not connected to the convenient outlet when the explosion occurred, and that the circuit for convenience outlet was in "OFF" position rendering the detector unoperational, and the upper right photo showed the screw of the metal clamp for the gas range inlet was loosened and the metal clamp itself was lowered about 1 ft from its intended location at point B, when recovered by SOCO,PNP after the explosion, consistent with our findings that it was removed and never reconnected to the gas range inlet.
